# ES4441 Residential Recessed uPVC Window on Timber Structure

## Weathertight Window Connection - TESCON EXTORA® Back Seal

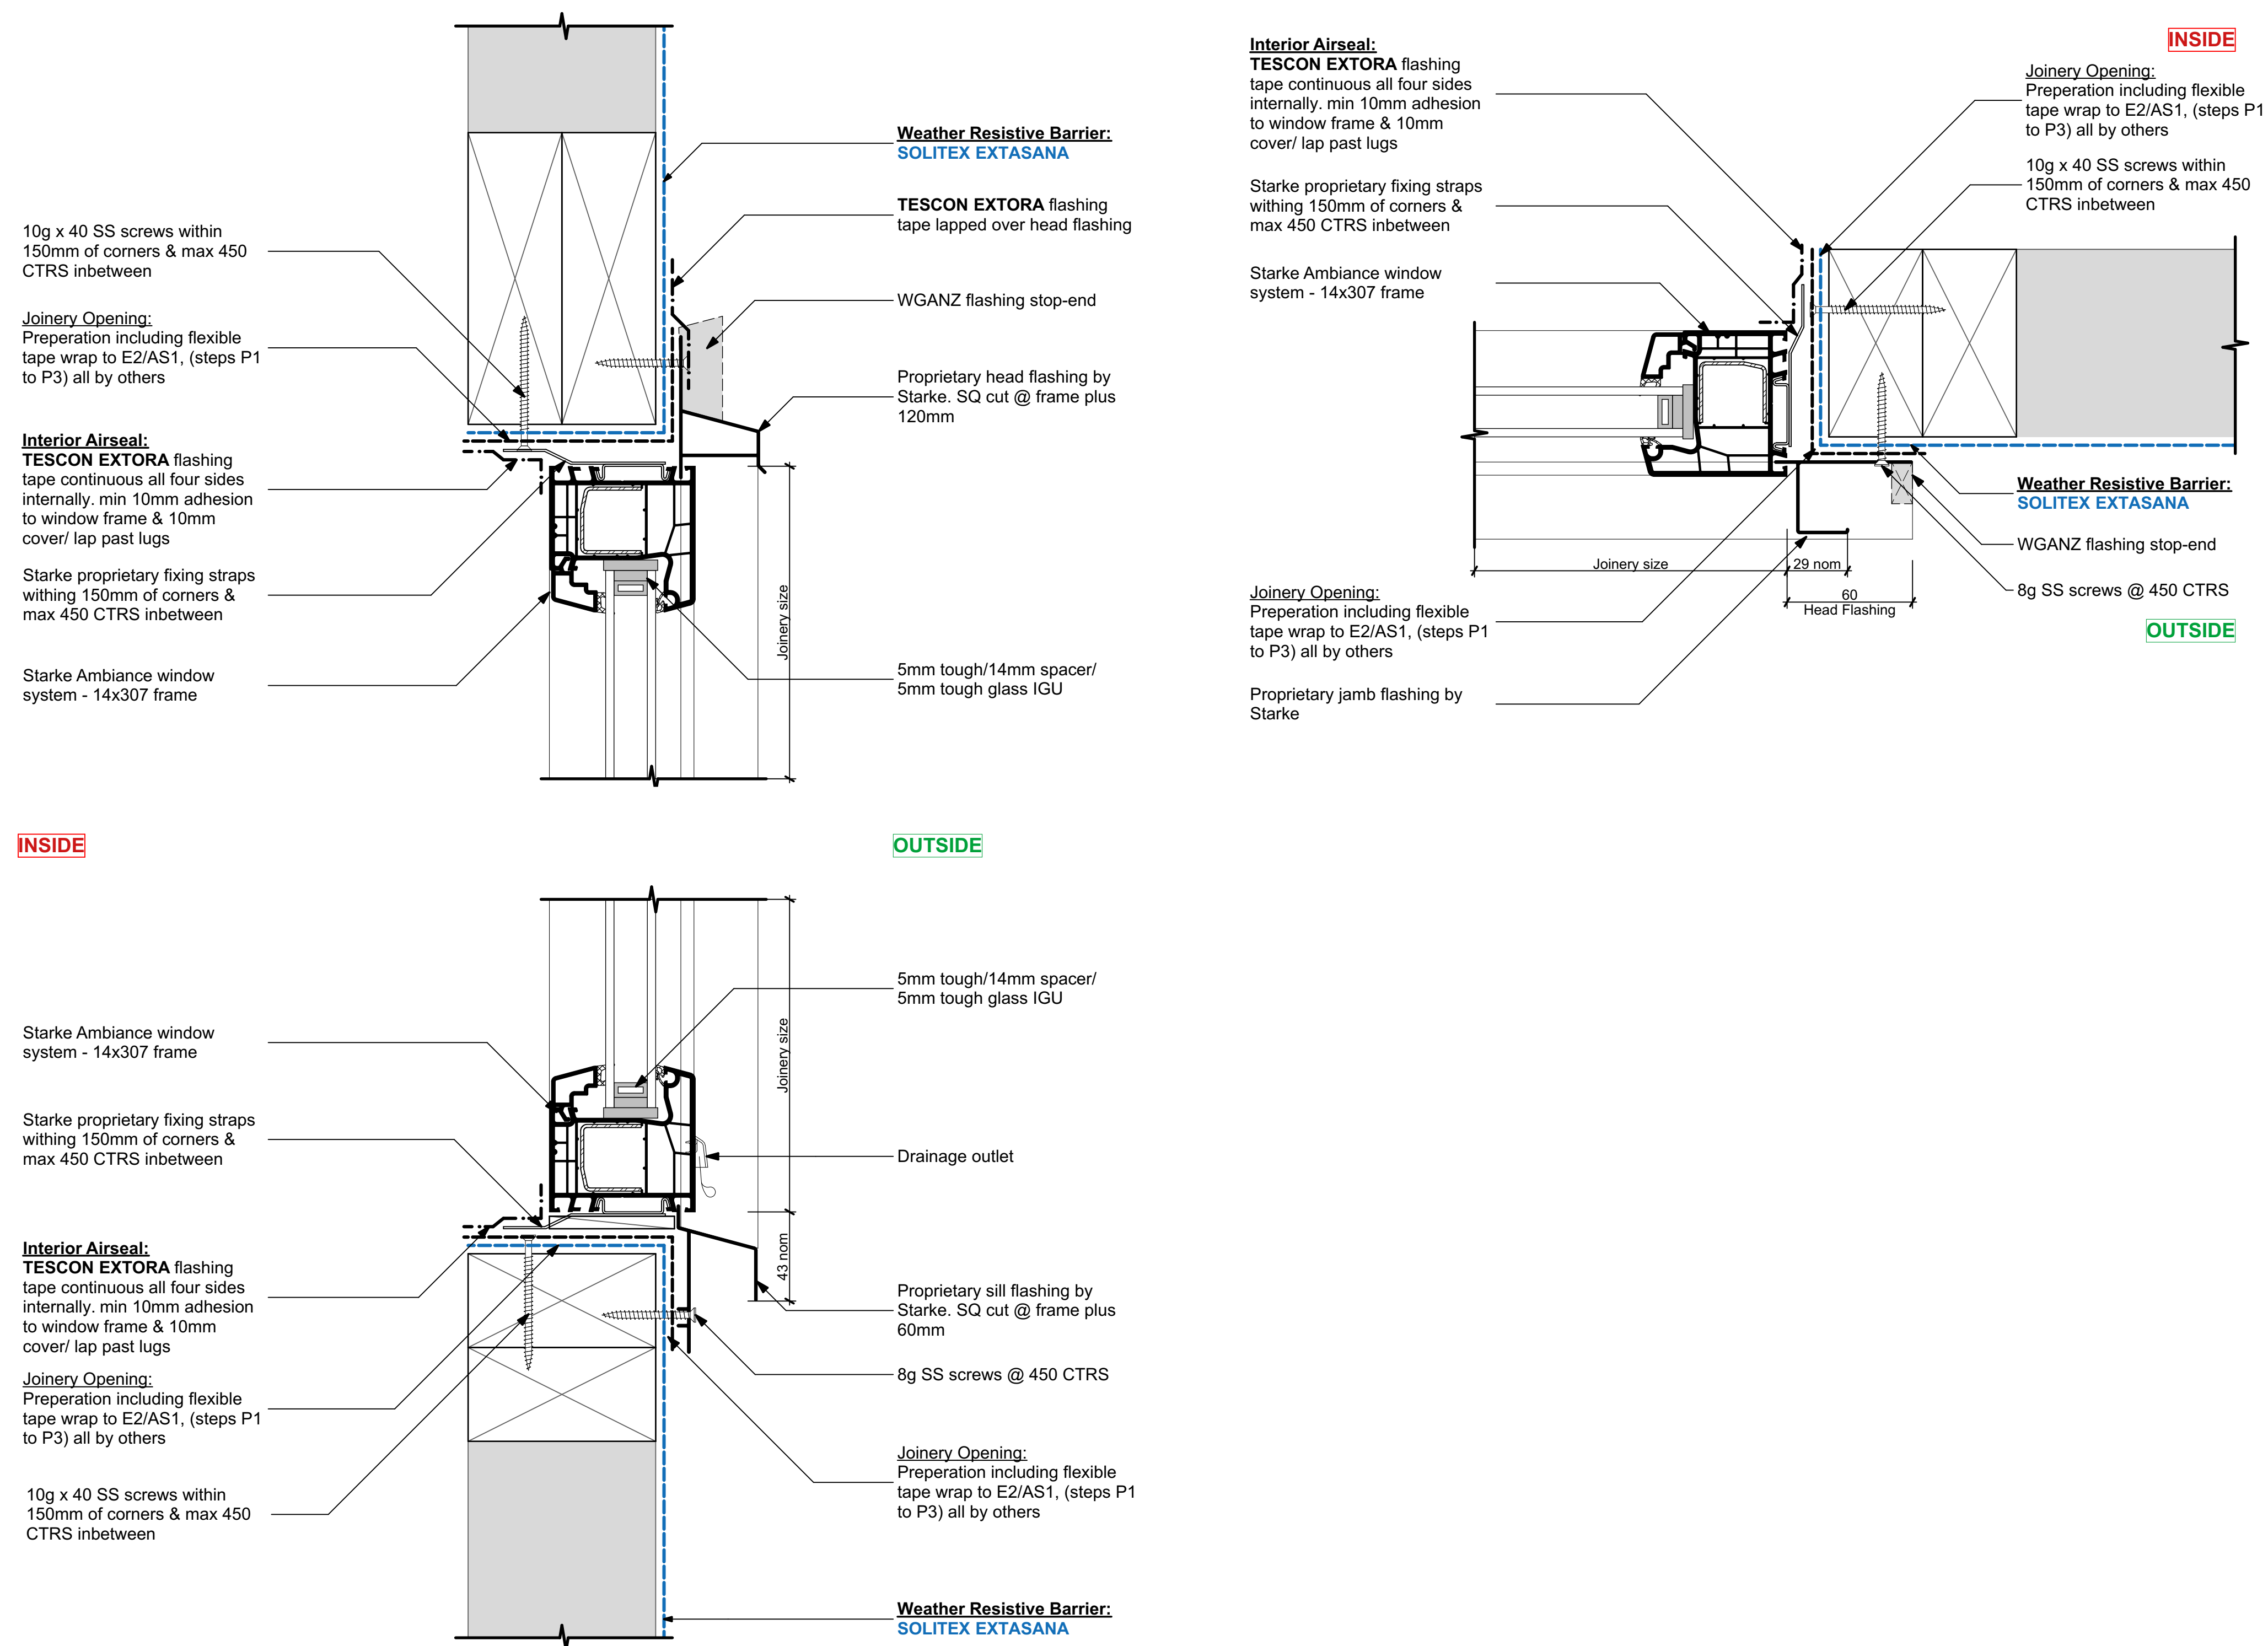
**Details derived from:**  
Test Report No. SWTL -R0063  
Starke 70- AS/NZS 4284  
Test Procedure SWTM-1.0AS\_NZS 4284 2008 Test Procedure v2  
Nominated SLS ± 2.00 kPa  
Seismic Serviceability ± 12.00 mm at 0.75 Hz

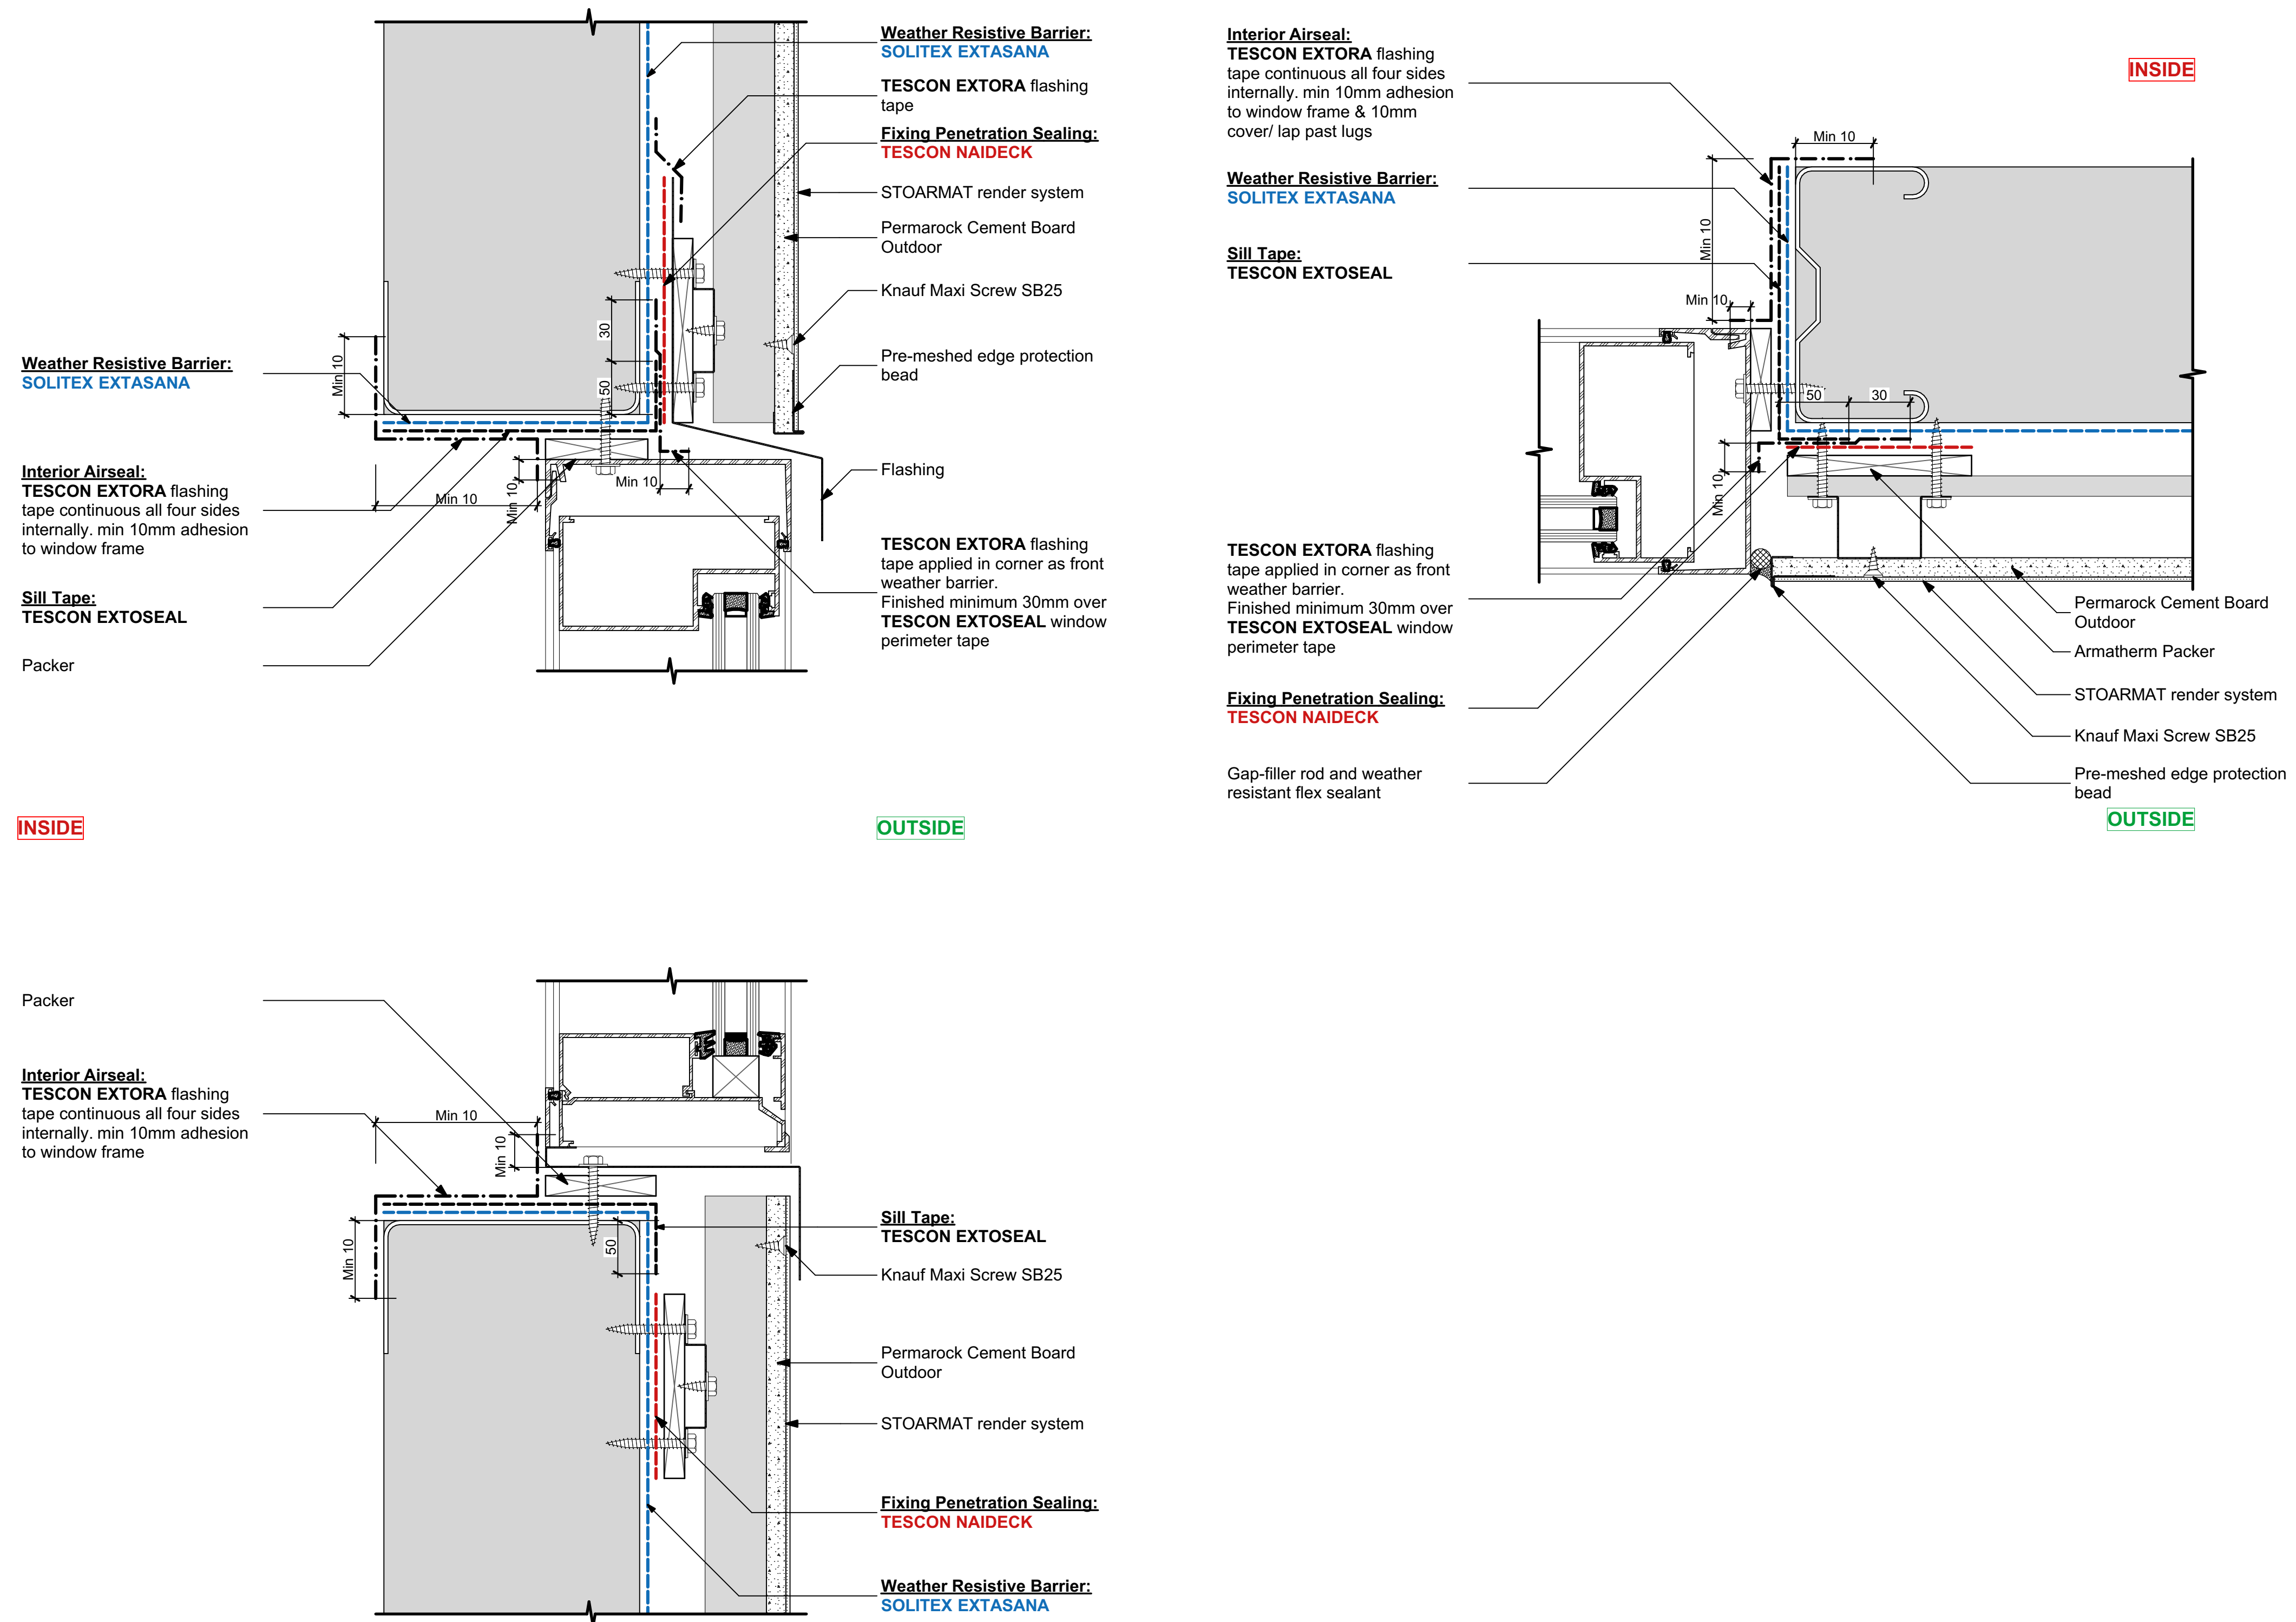
# ES4241 Commercial Flush Aluminium Window on Metal Structure

## Weathertight Window Connection - TESCON EXTORA® Back Seal

Details derived from:  
Test Report No. 2024-042-S1-Ncc2022  
Knauf Permarock Outdoor Facade  
AS/NZS4284:2008 Testing of Facades  
Nominated SLS ± 2.00kPa.

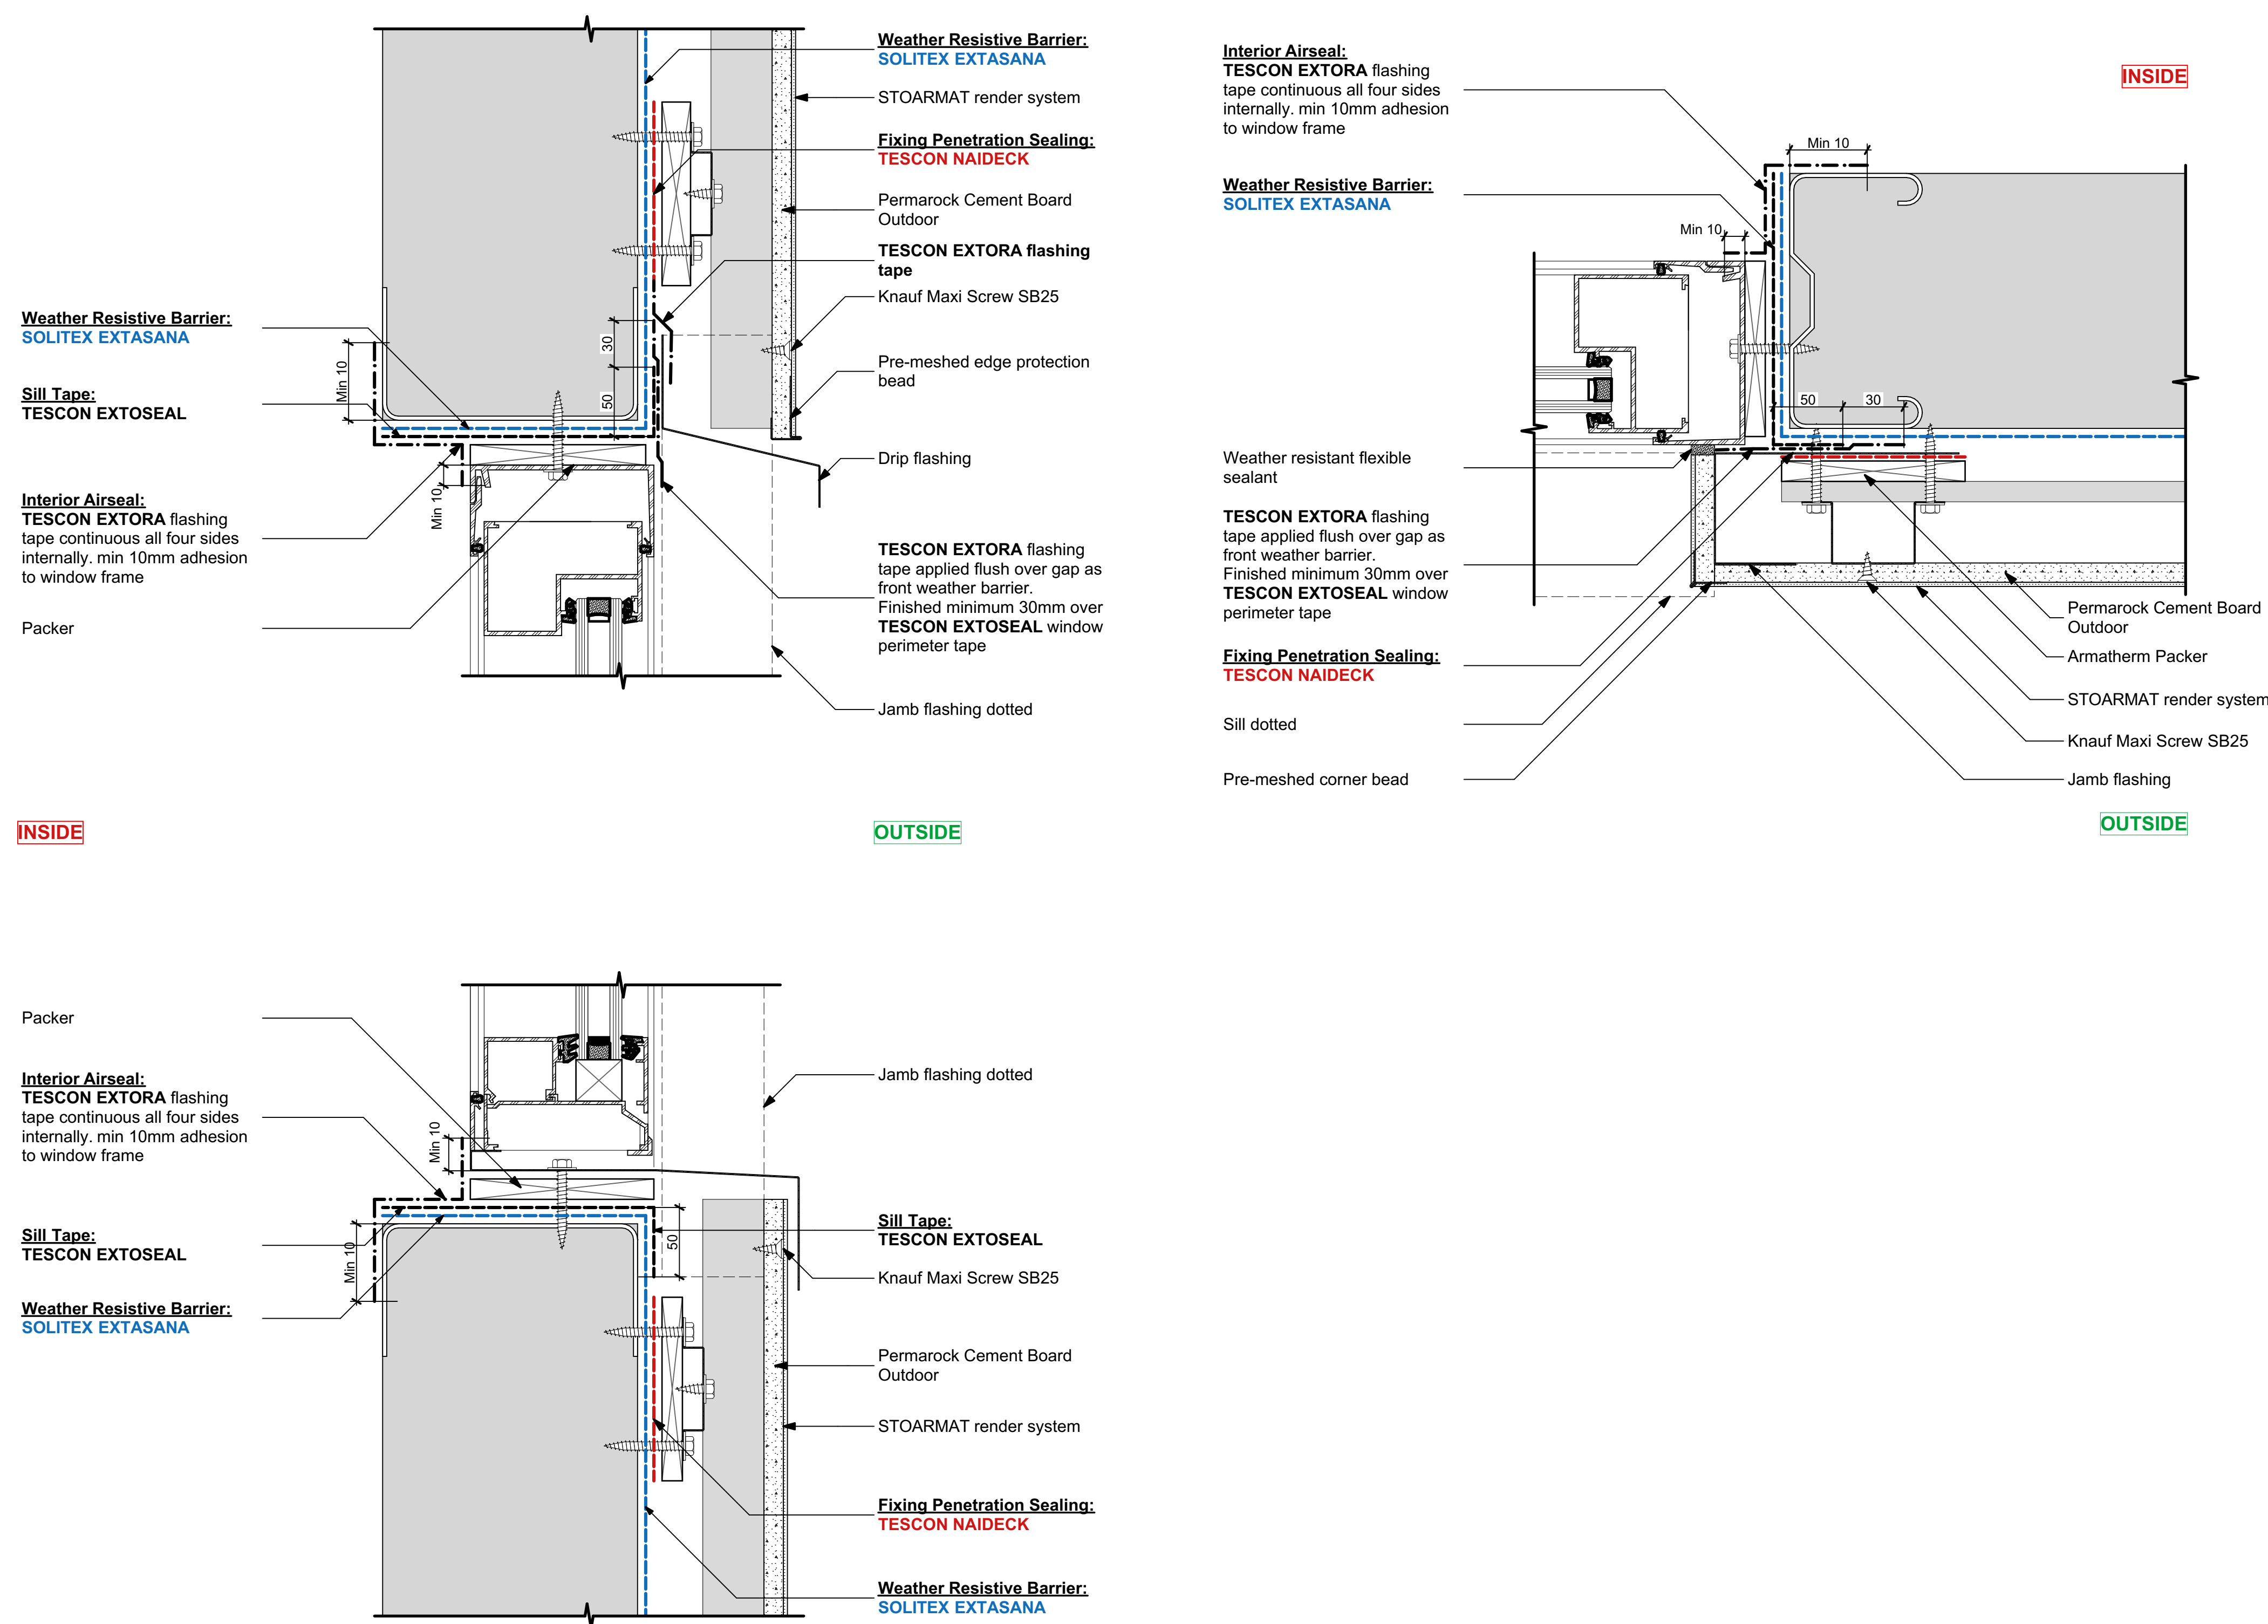
# ES4242 Commercial Recessed Aluminium Window on Metal Structure

## Weathertight Window Connection - TESCON EXTORA® Back Seal

Details derived from:  
Test Report No. 2024-042-S1-Ncc2022  
Knauf Permarock Outdoor Facade  
AS/NZS4284:2008 Testing of Facades  
Nominated SLS ± 2.00kPa.

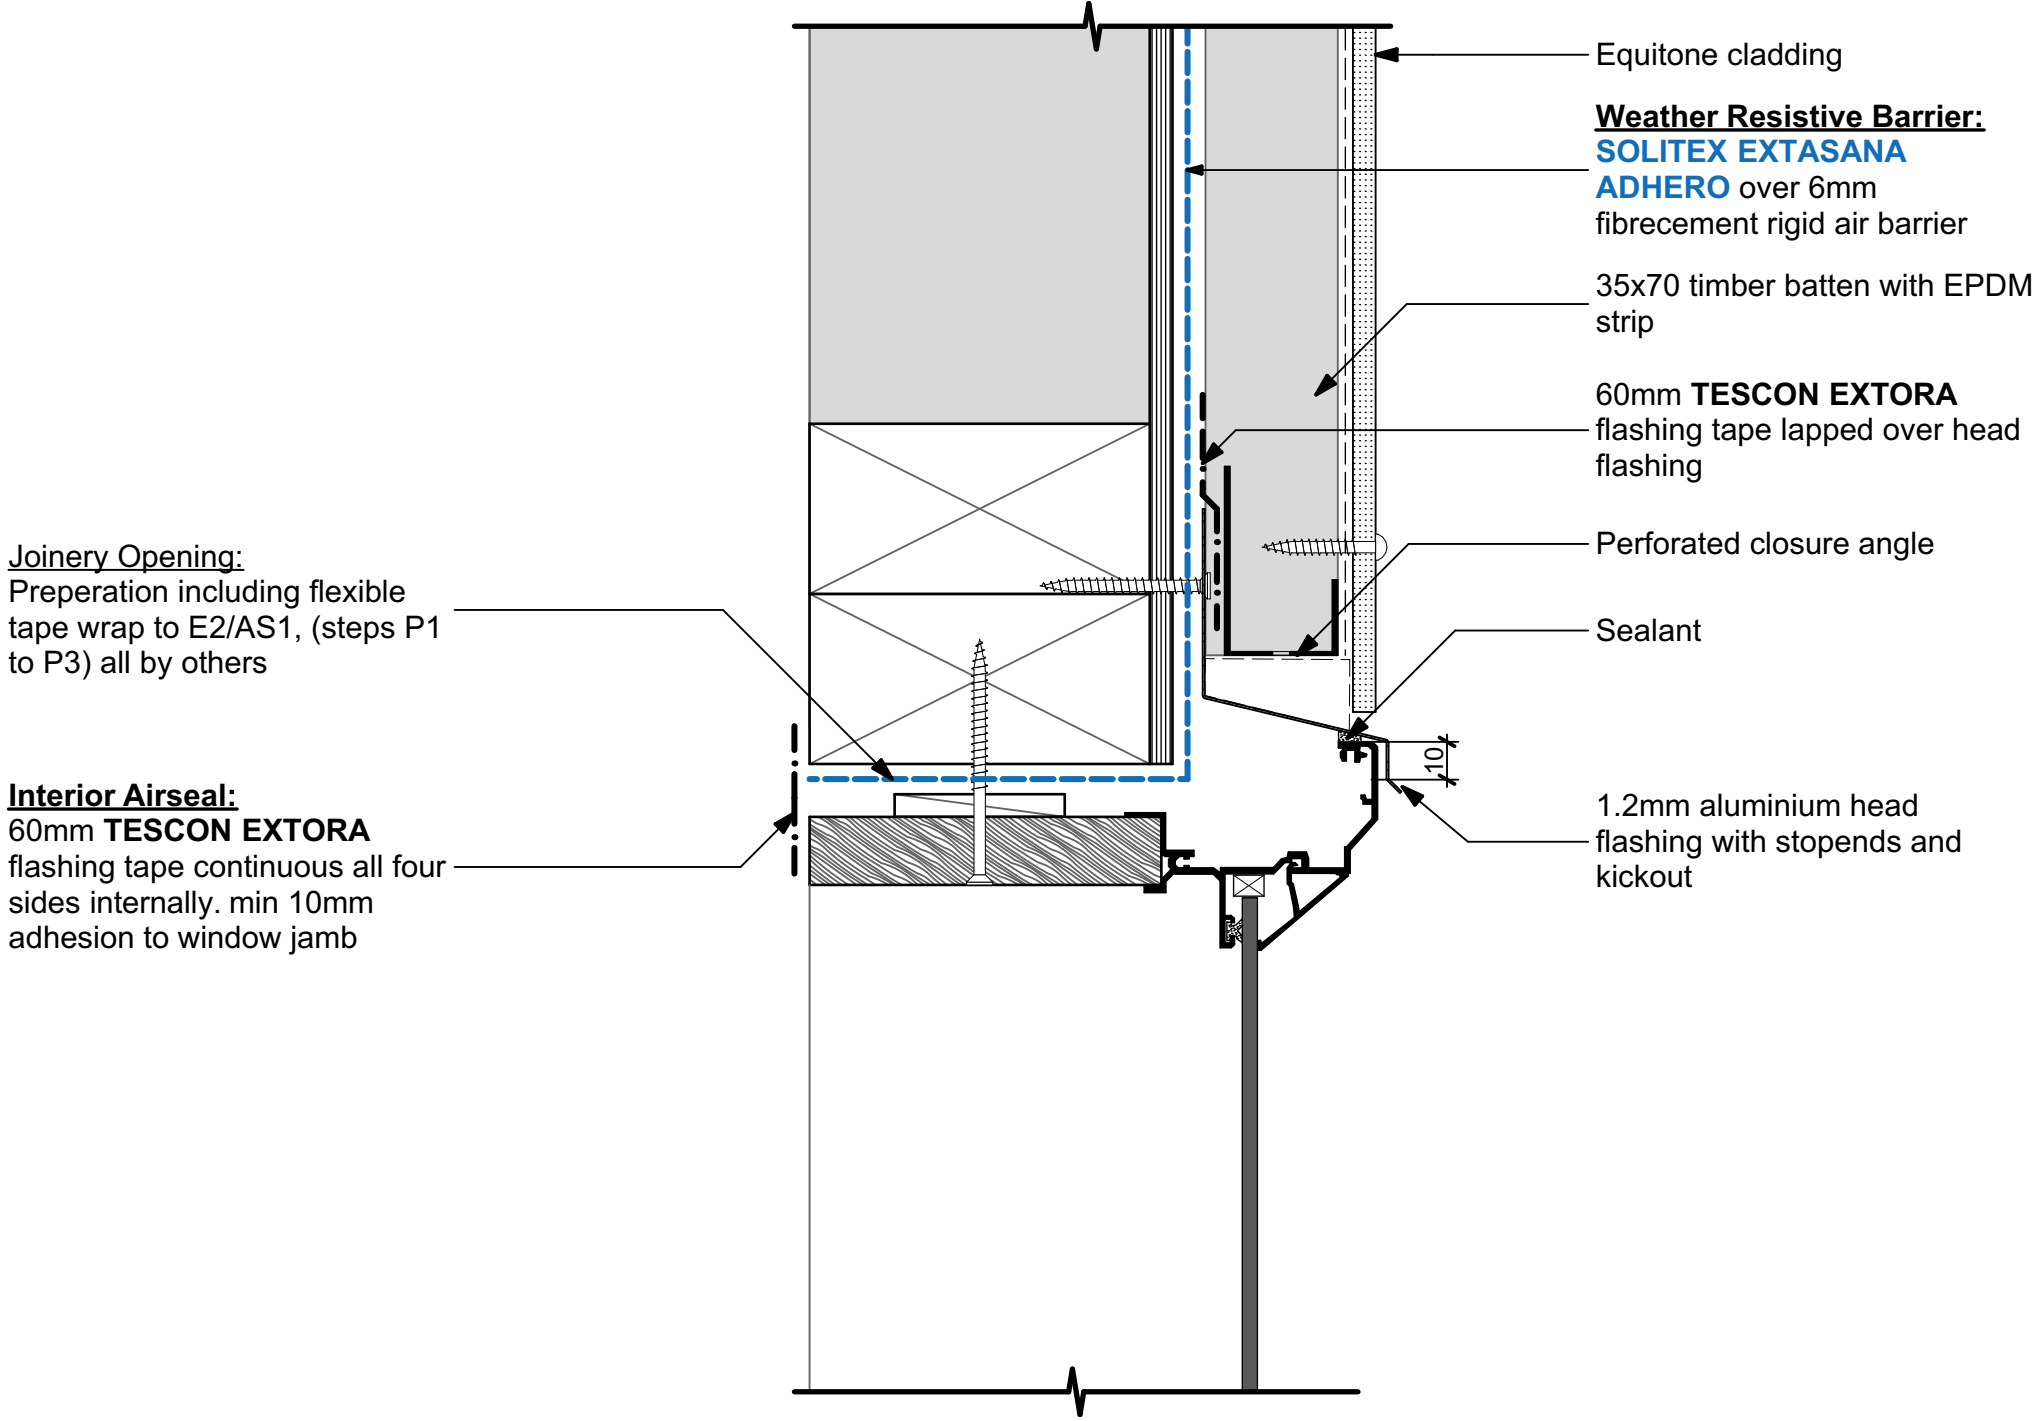
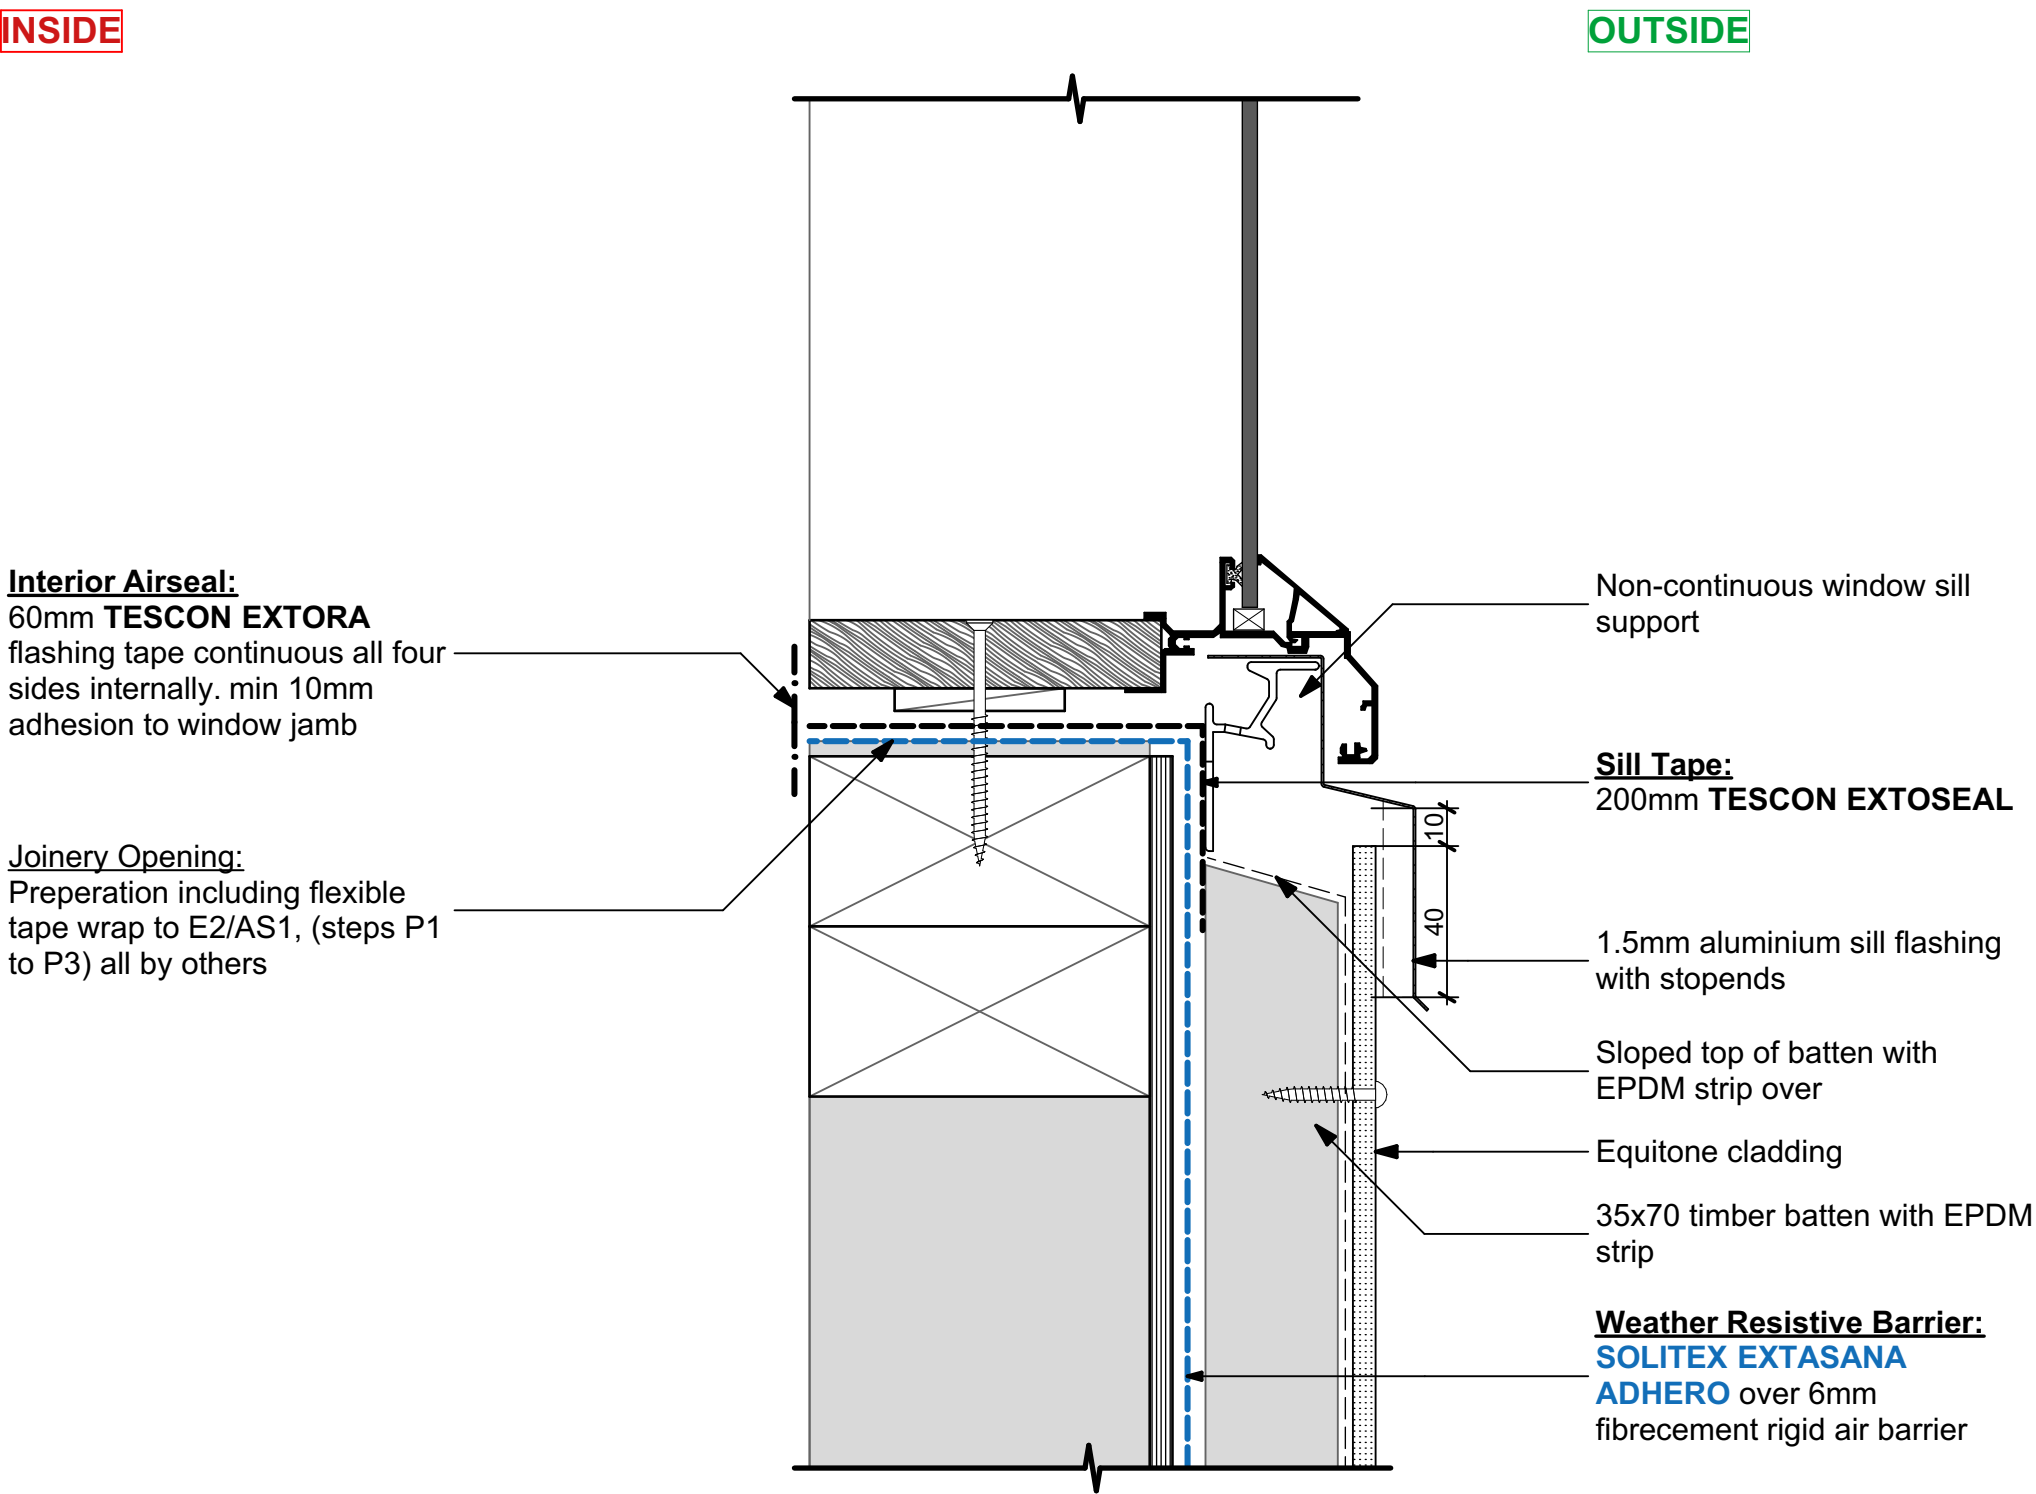
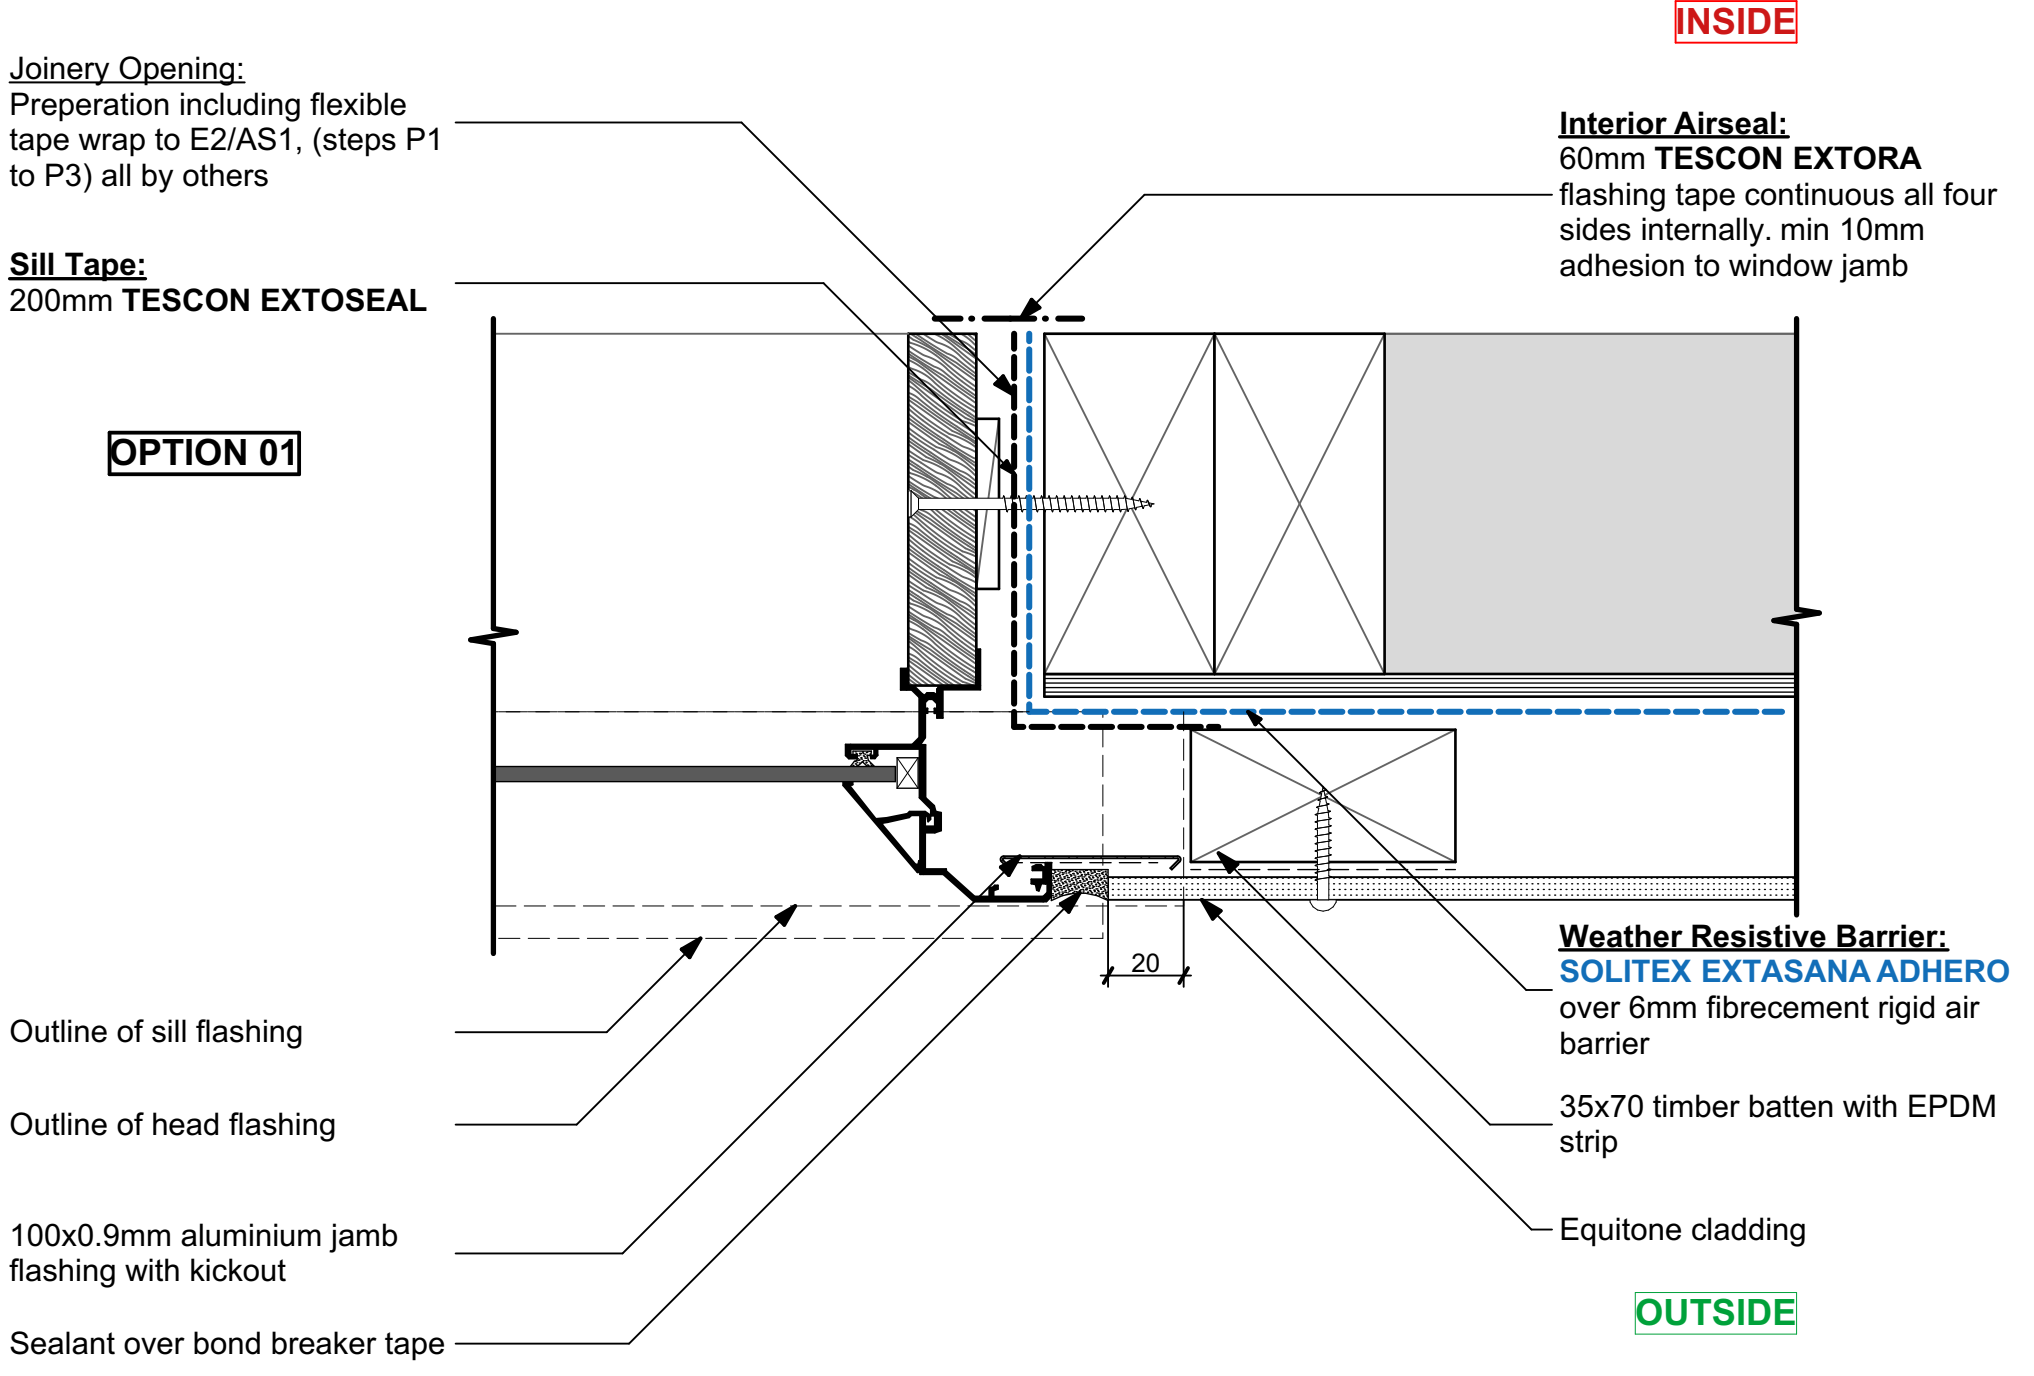
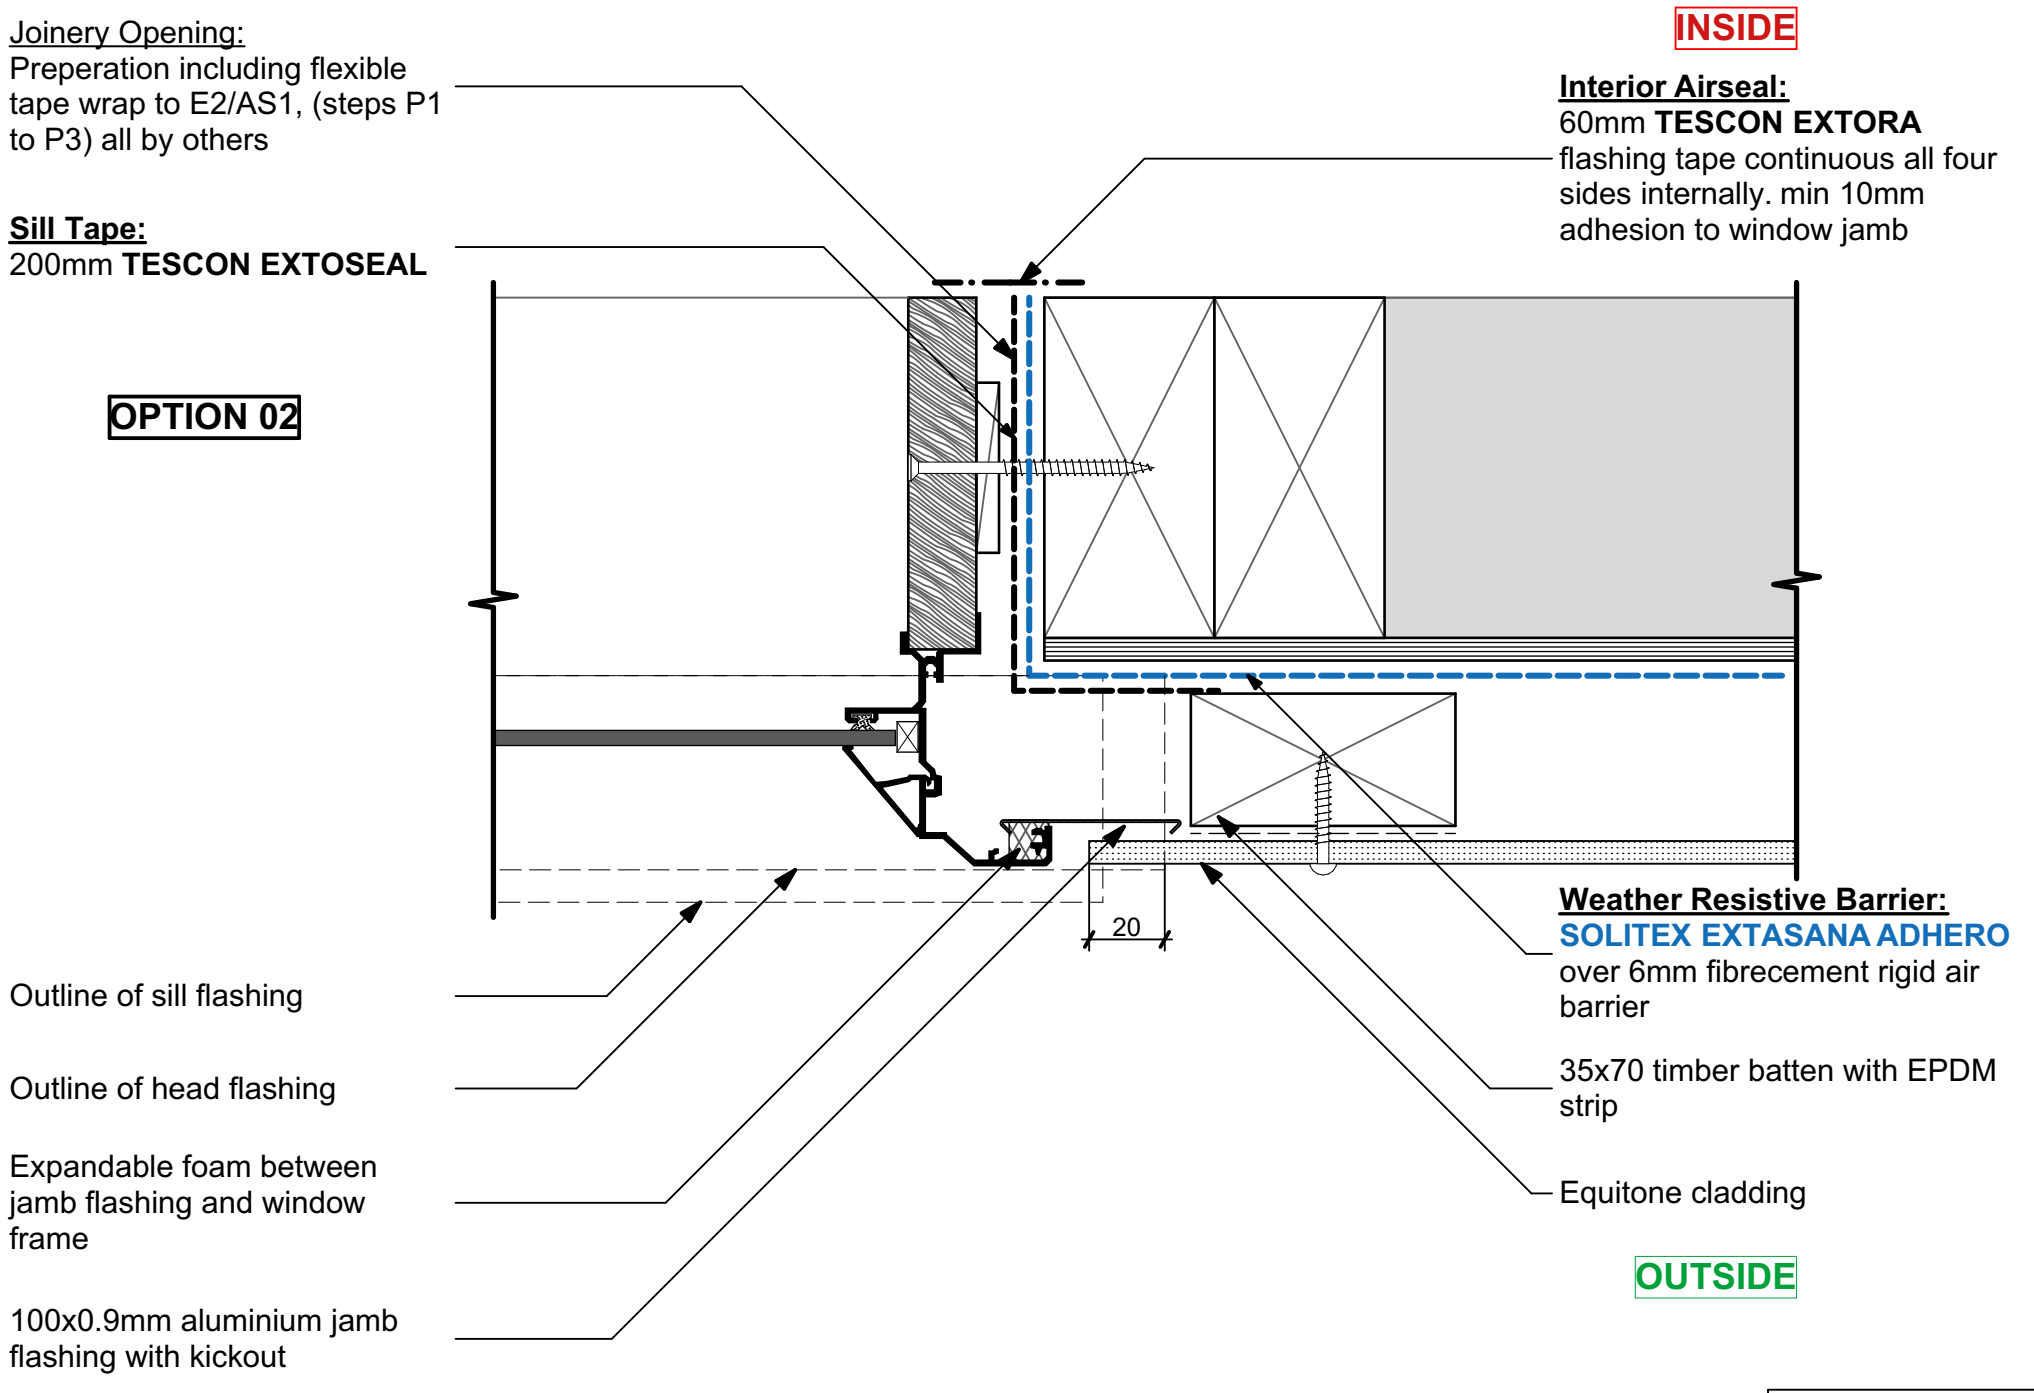
# ES4243 Residential Flush Aluminium Window on Timber Structure

## Weathertight Window Connection - TESCON EXTORA® Back Seal

**Details derived from:**  
Test Report No. FT-R1040

E2/VM2 testing of cladding system installation details for 8mm Equitone® on 35 x 70 H3.1 SG6 KD timber cavity battens for Etex Group®

Nominated SLS ± 2.25kPa.
