# ES4441 Residential Recessed uPVC Window on Timber Structure

## Weathertight Window Connection - TESCON EXTORA® Back Seal

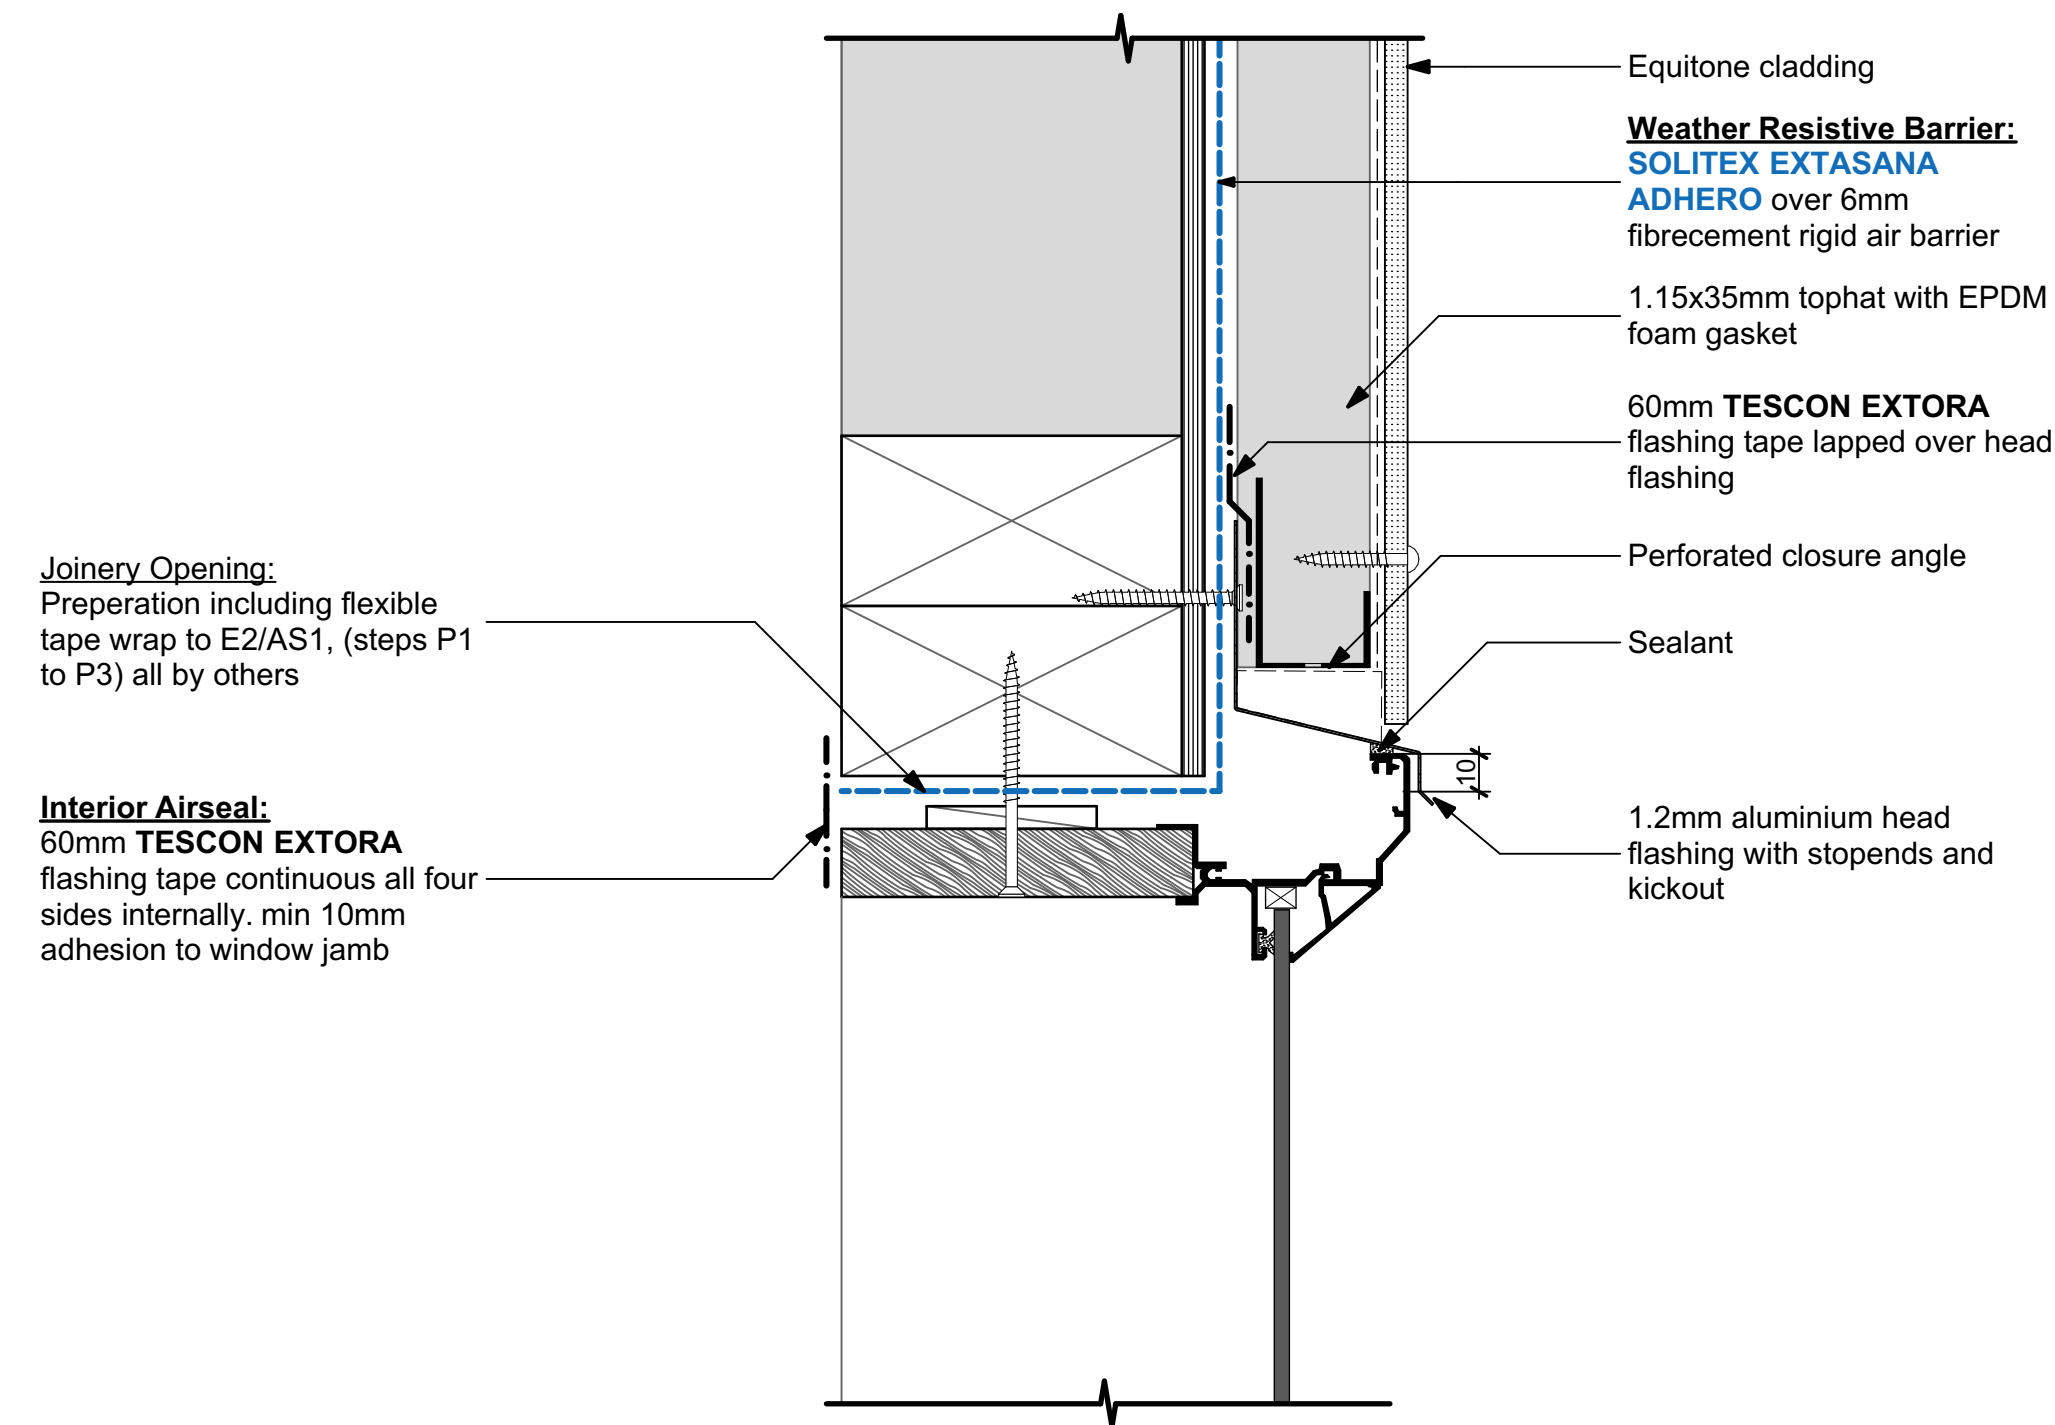
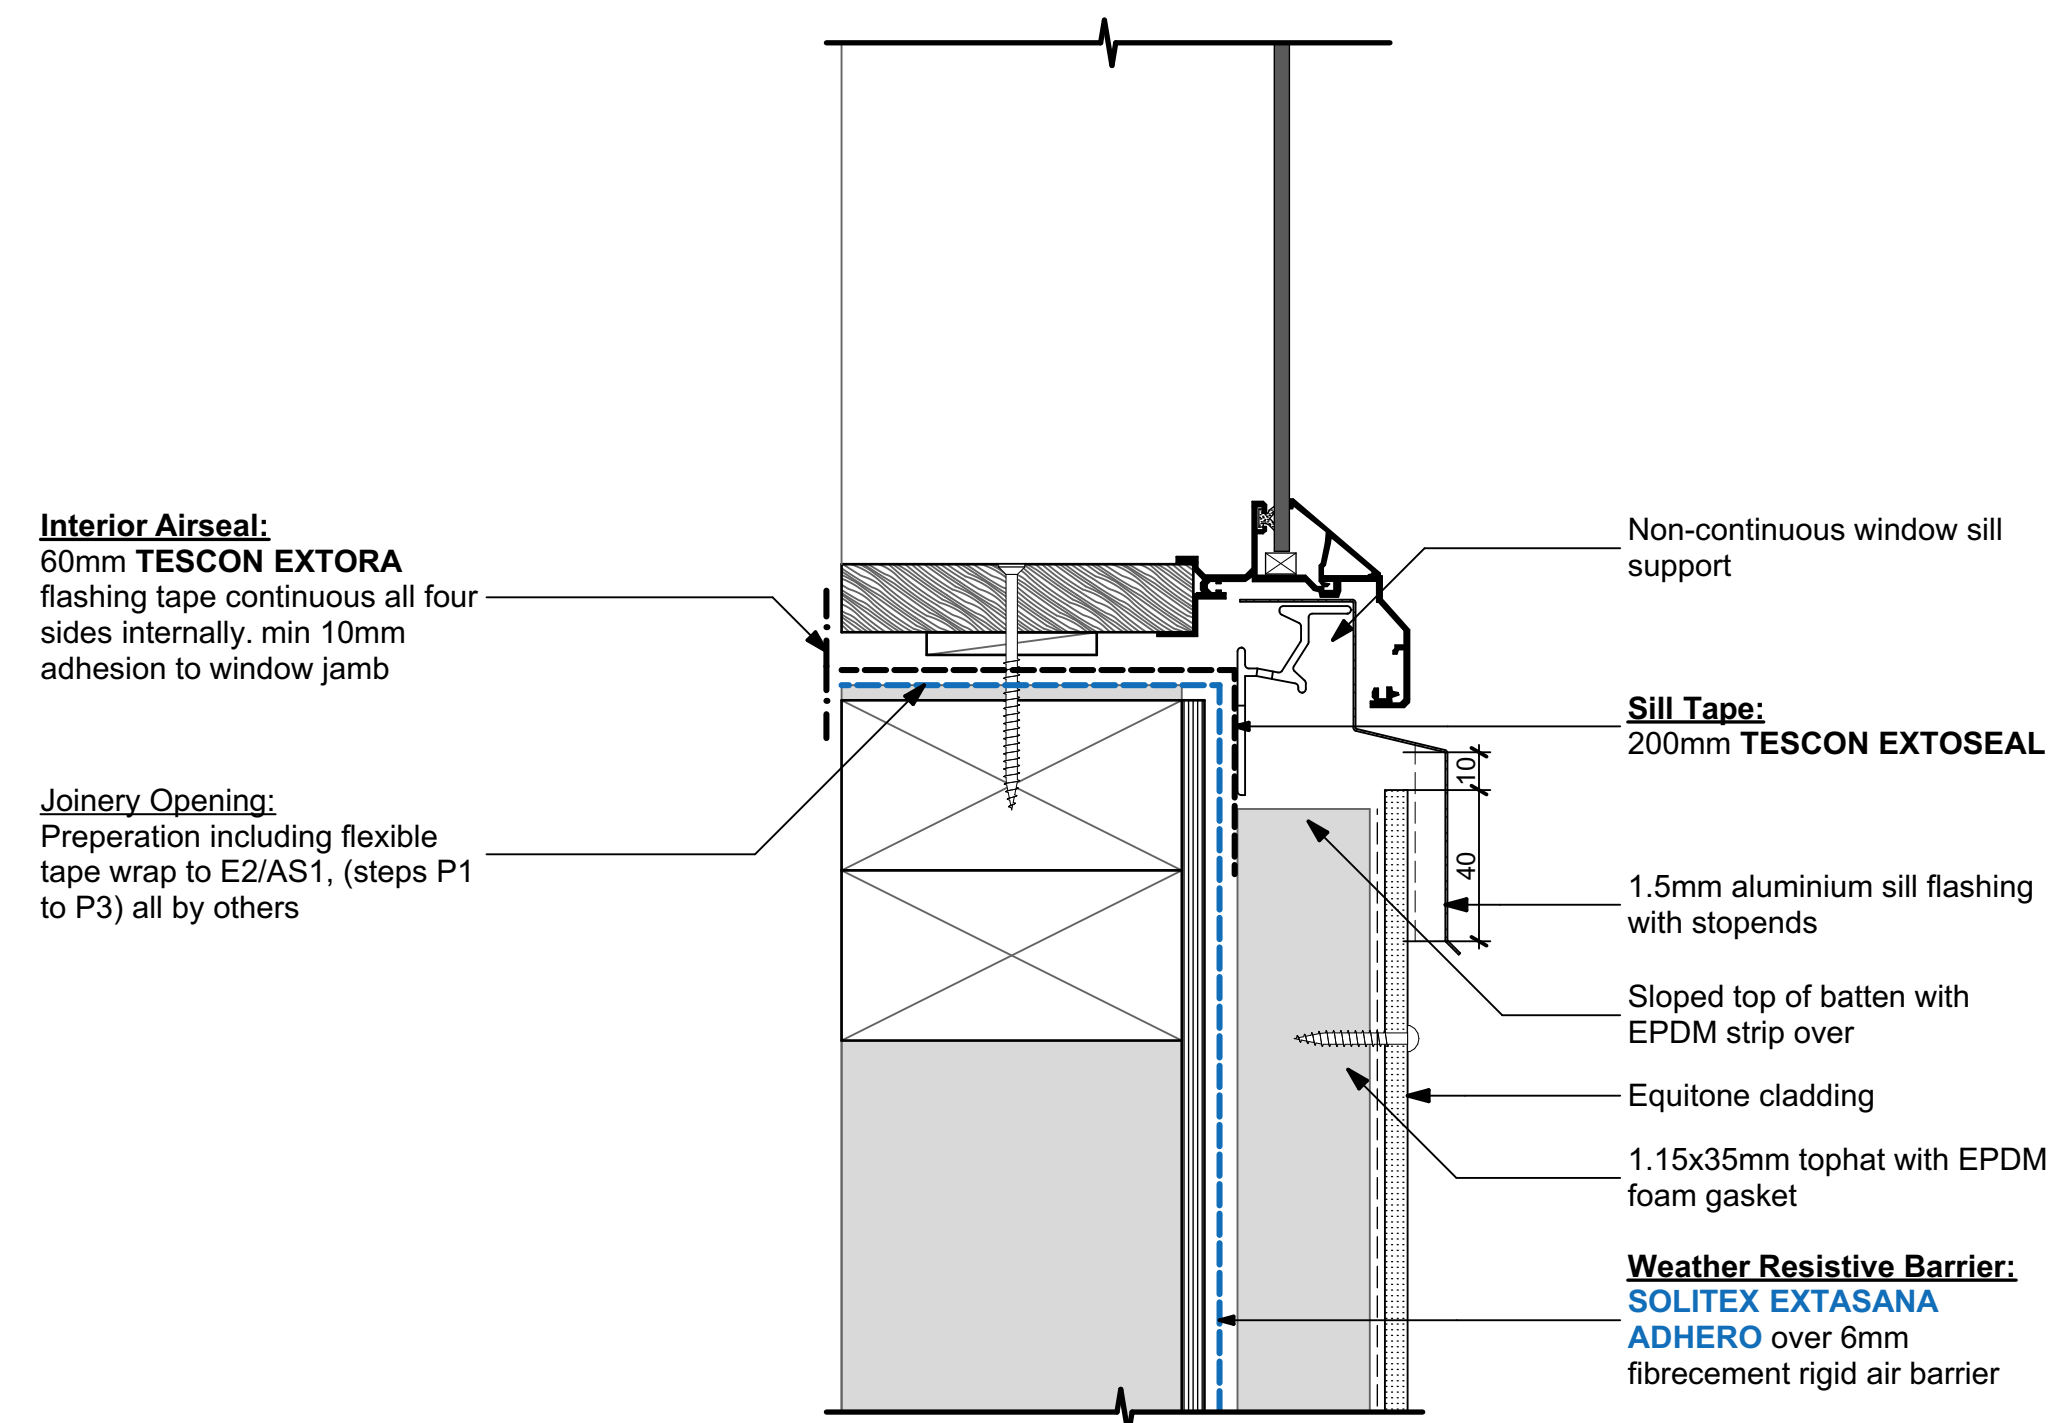
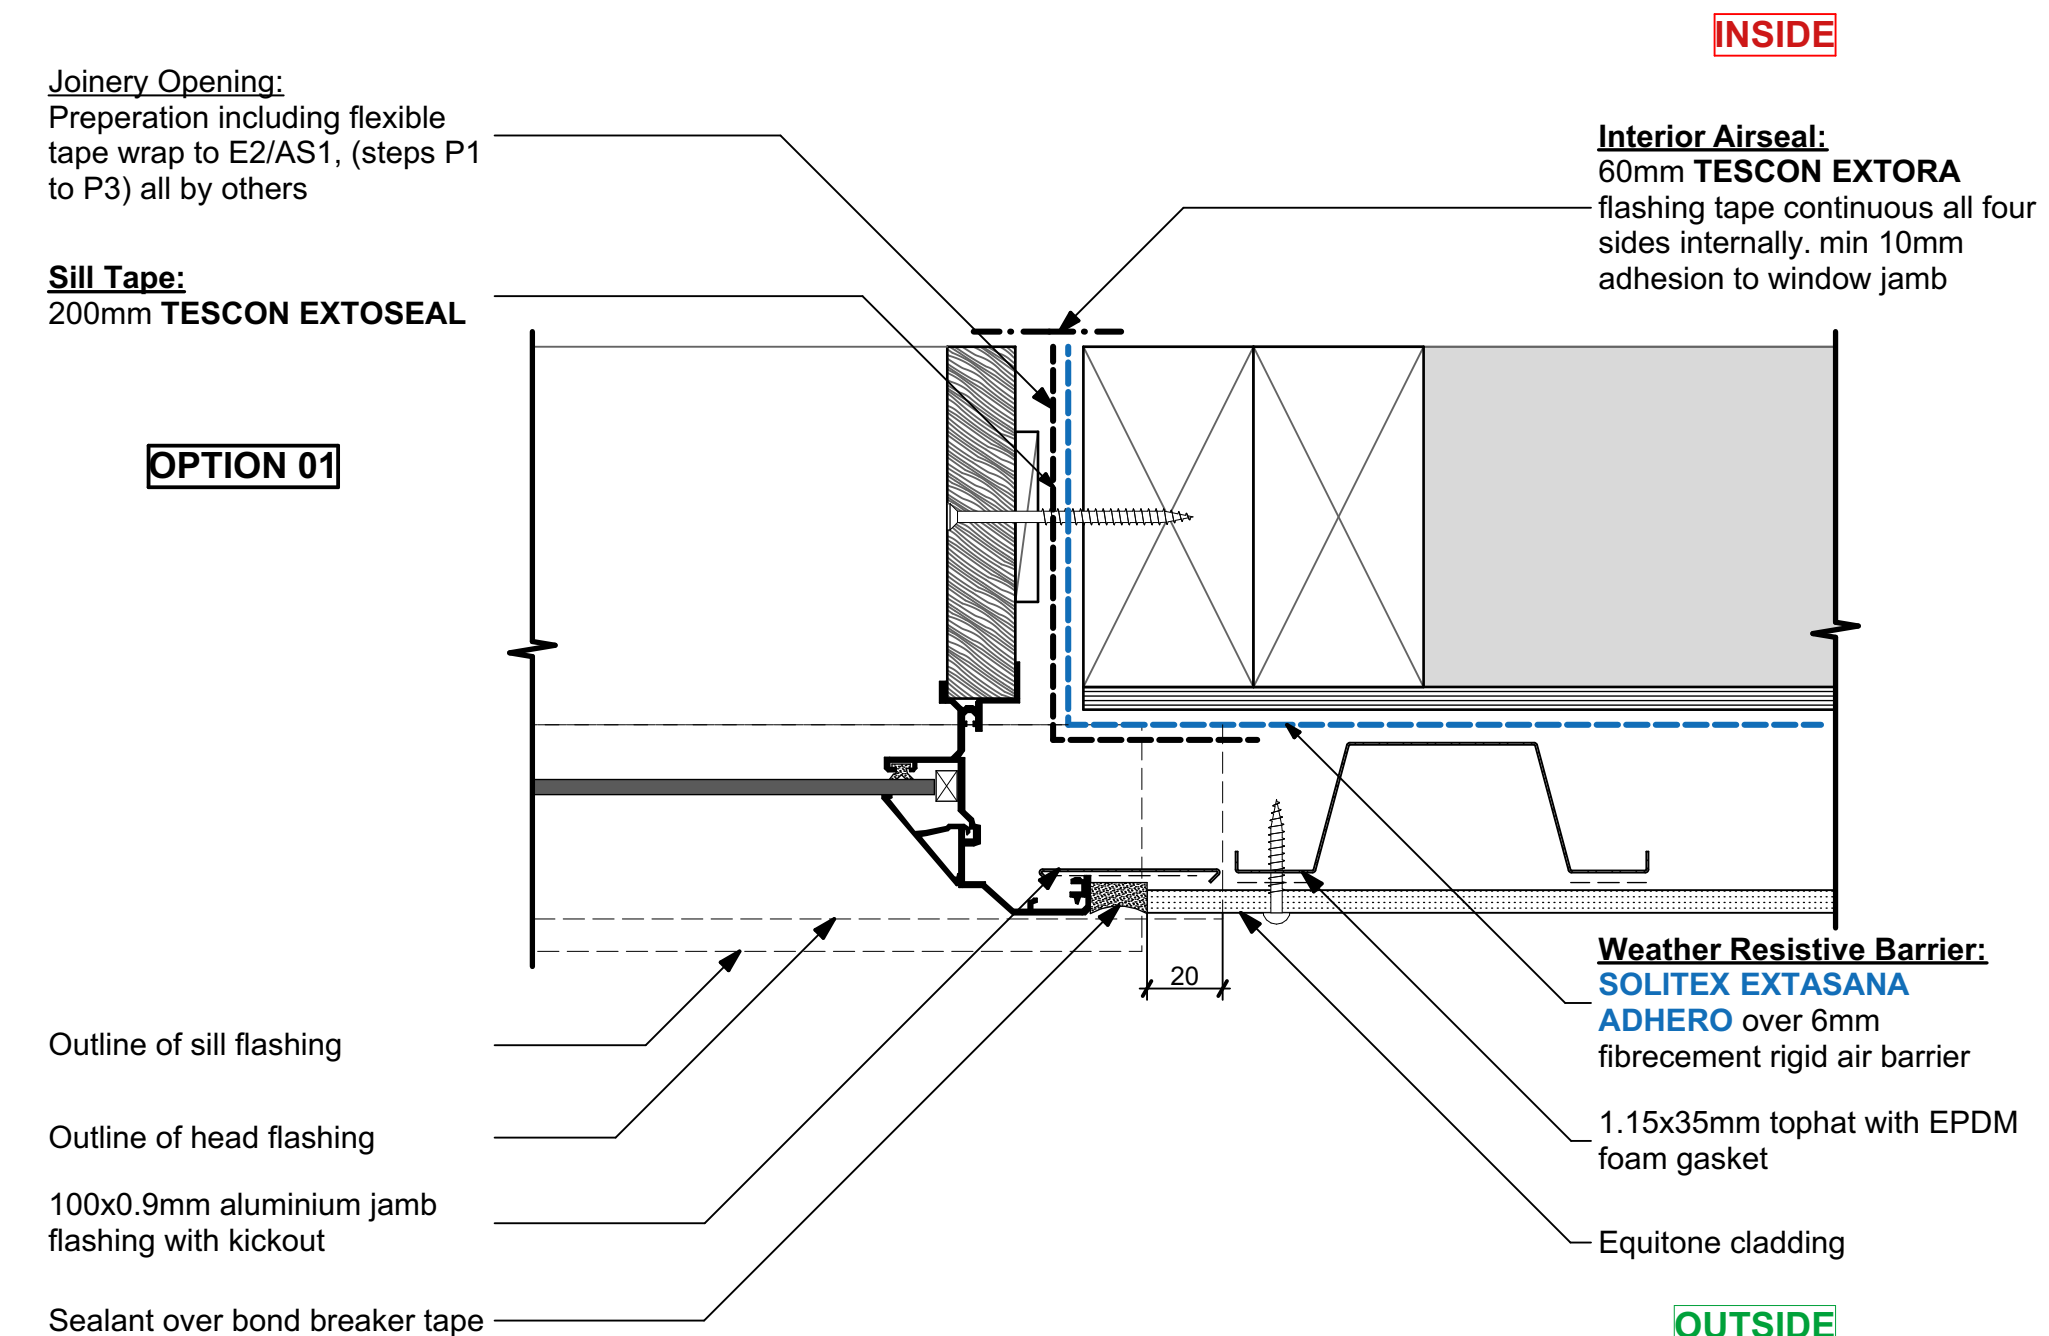
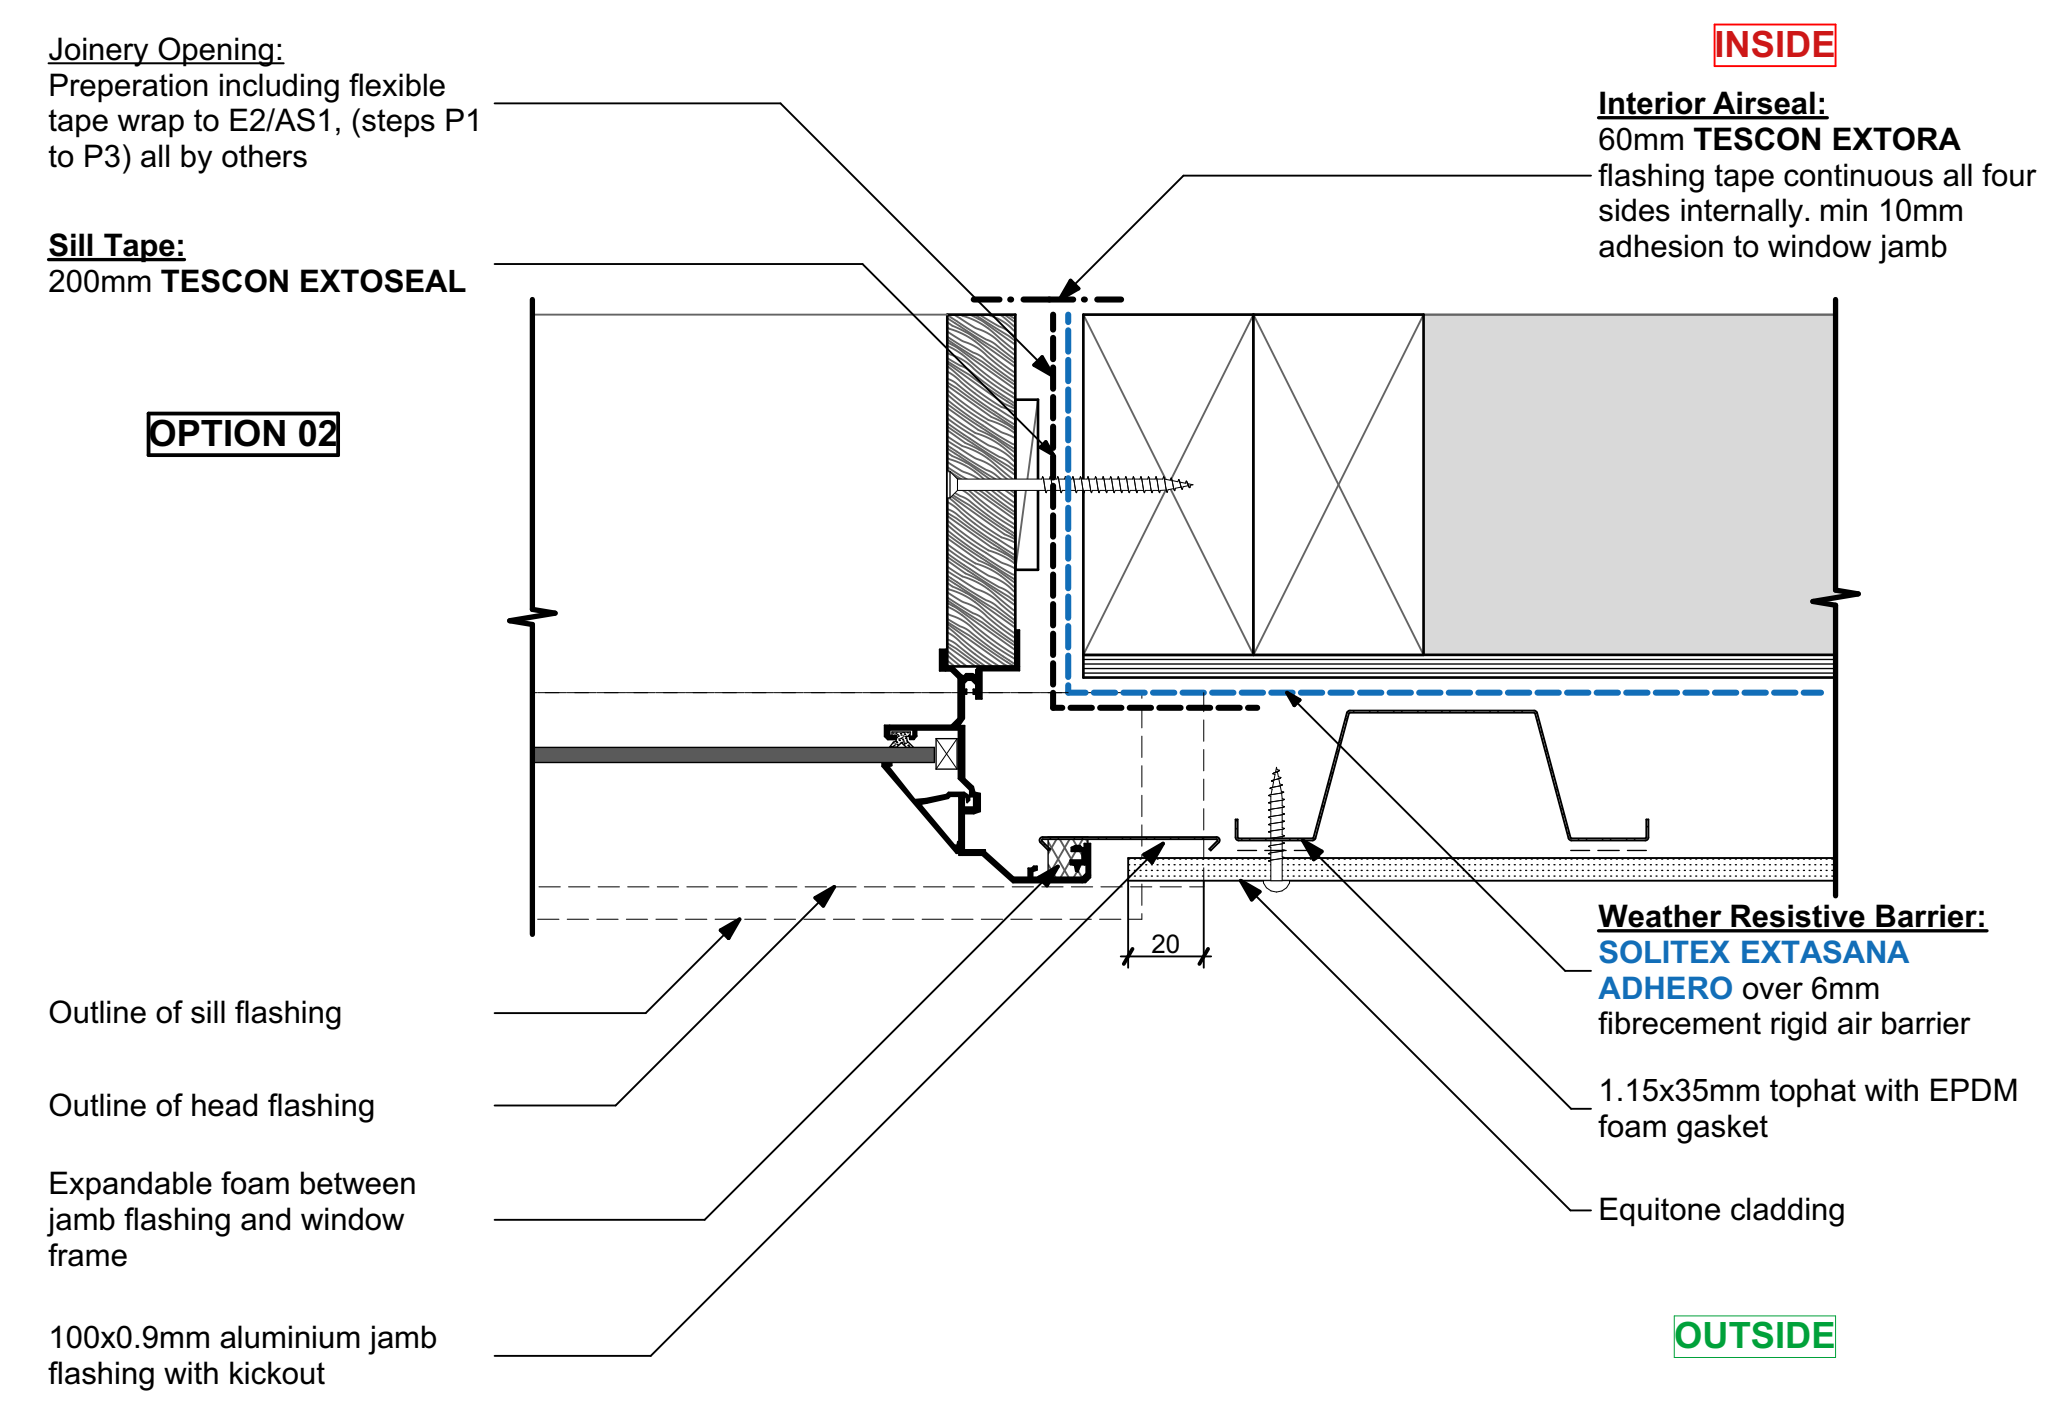
# ES4244 Residential Flush Aluminium Window on Timber Structure

## Weathertight Window Connection - TESCON EXTORA® Back Seal

**Details derived from:**  
E2/VM2 testing of cladding system installation details for 8mm Equitone on 35 mm x 1.15 BMT Zincalume Tophat cavity battens for Etex Group

Test Report No. FT-R1042

Nominated SLS  $\pm 2.25$ kPa.

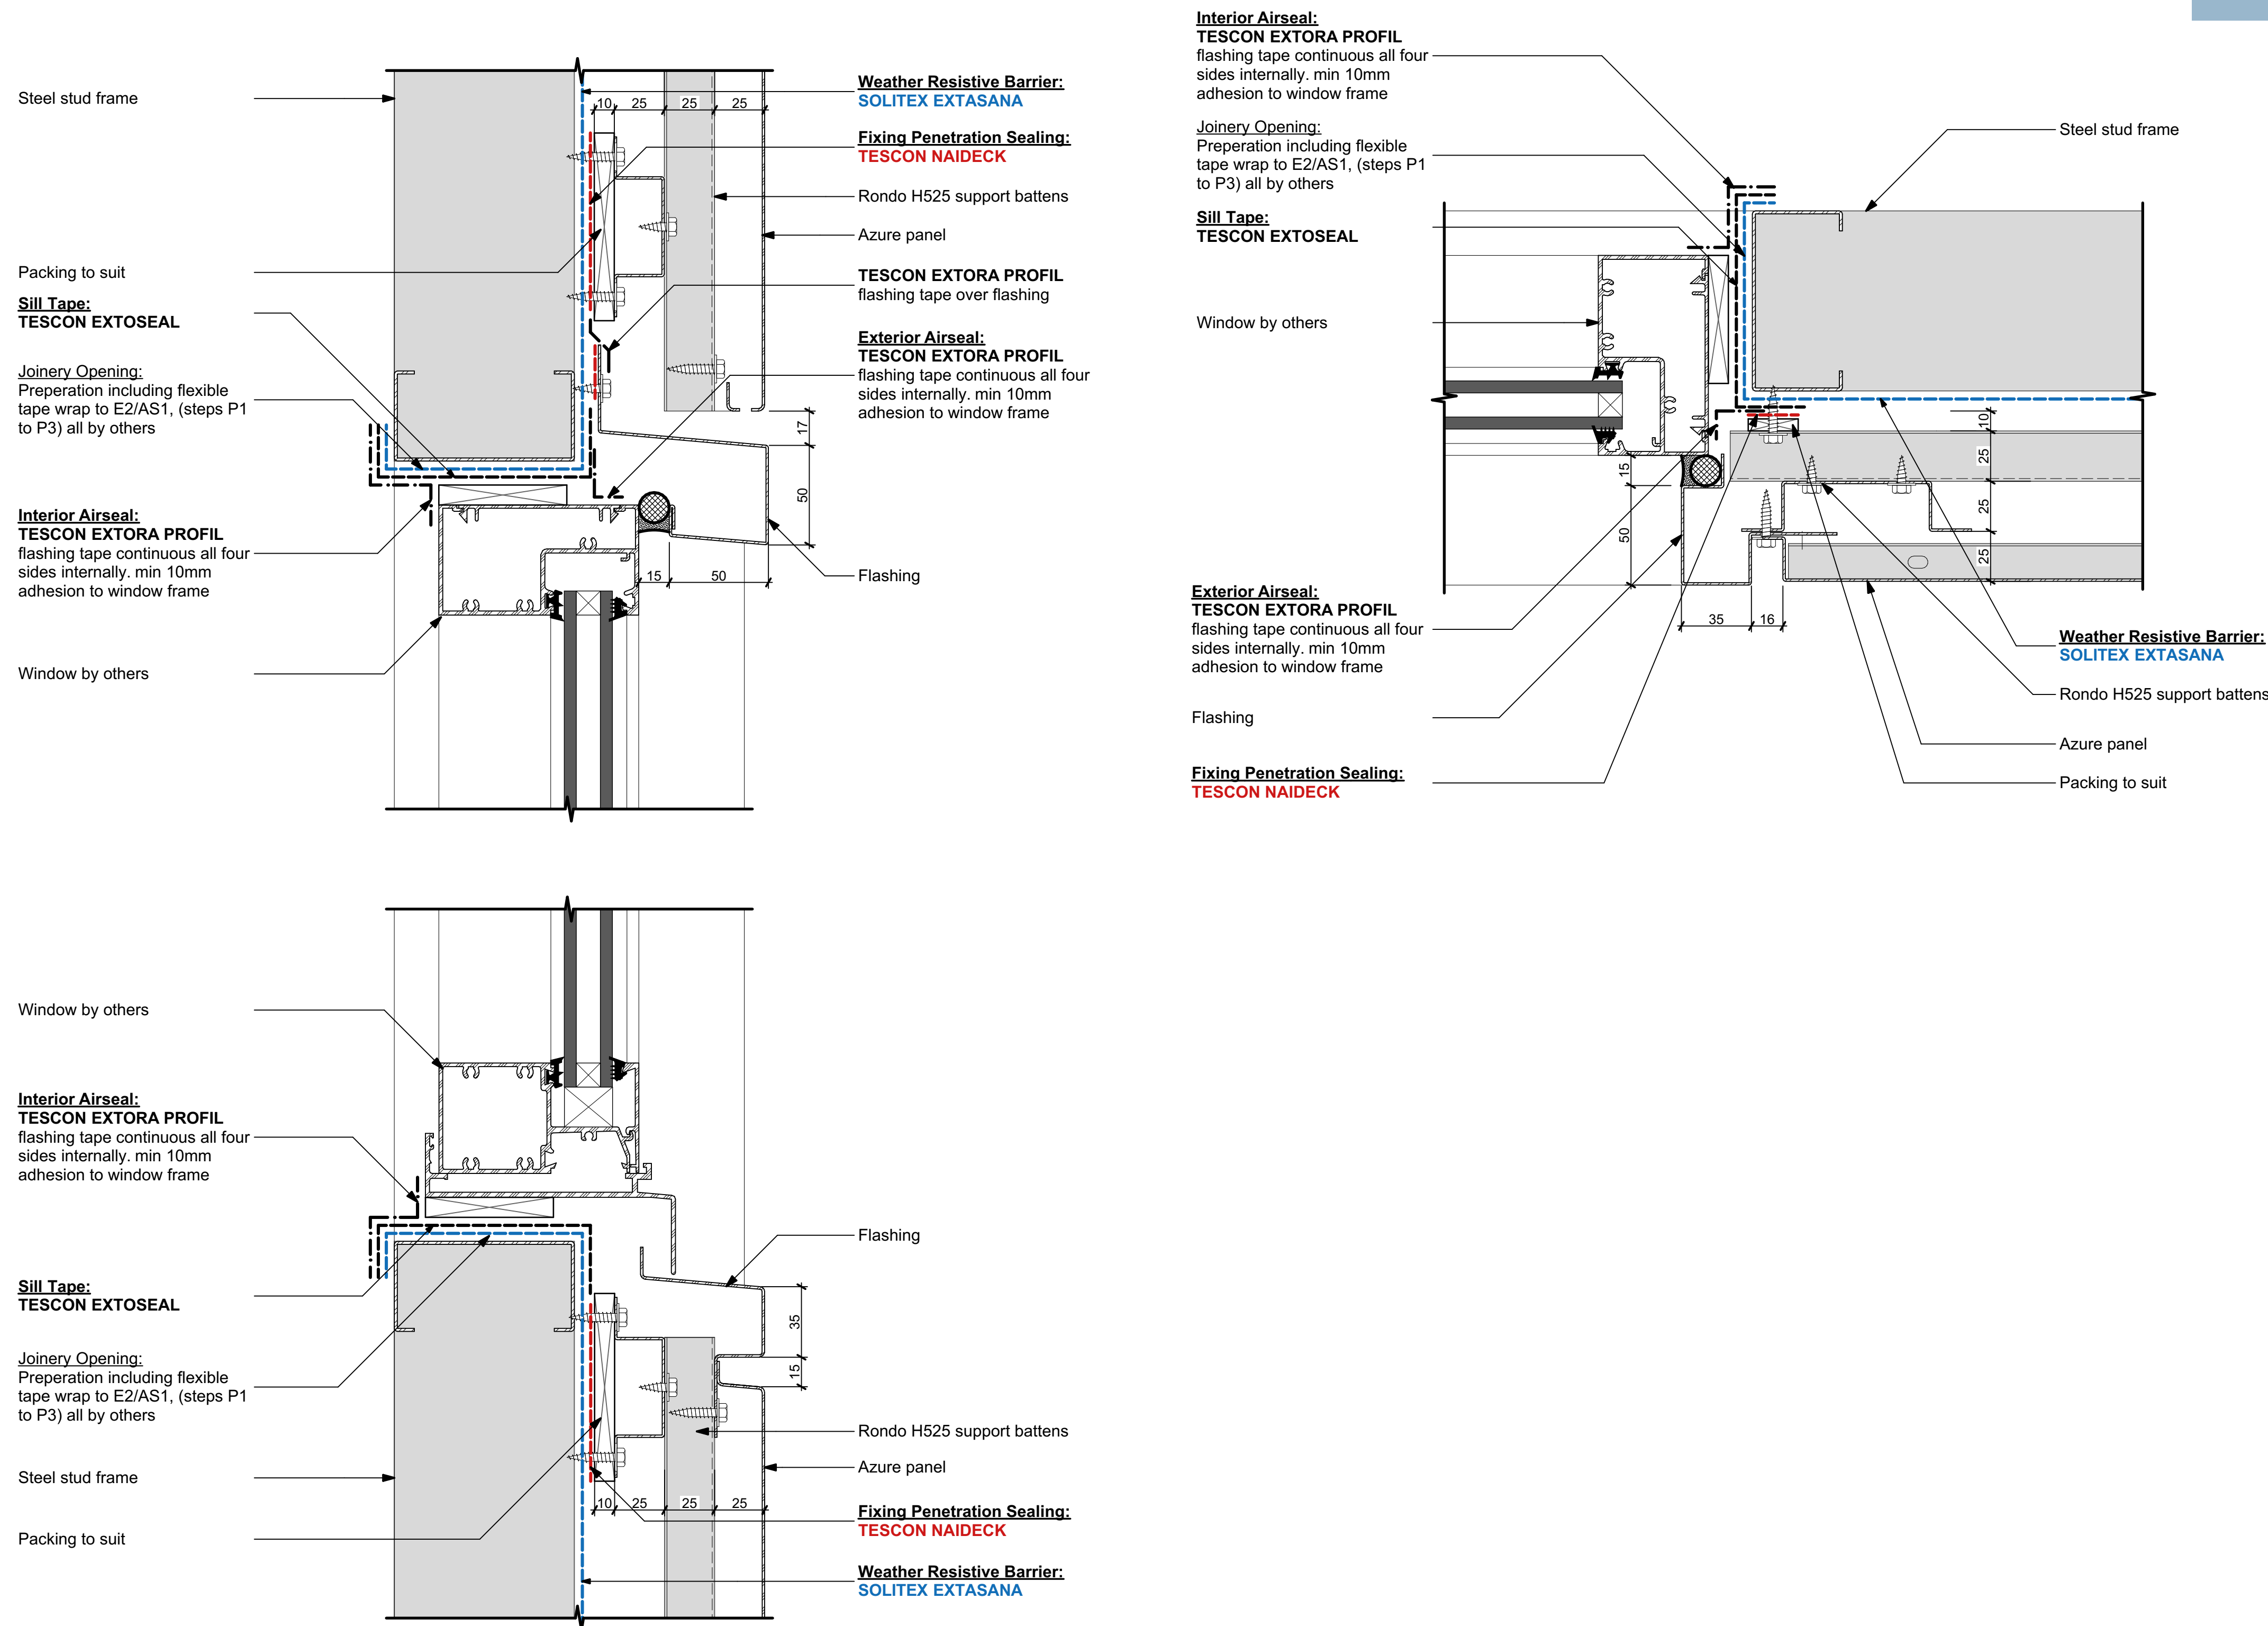
# ES4245 Commercial Recessed Aluminium Window on Metal Structure

## Weathertight Window Connection - TESCON EXTORA® Back Seal

Details derived from:  
Lysaght AZURE © 100 Panel with Pro Clima SOLITEX  
EXTASANA © Weather Resistive Barrier

Test Report No. 2024-003-S1-R1

Nominated SLS ± 1.63kPa

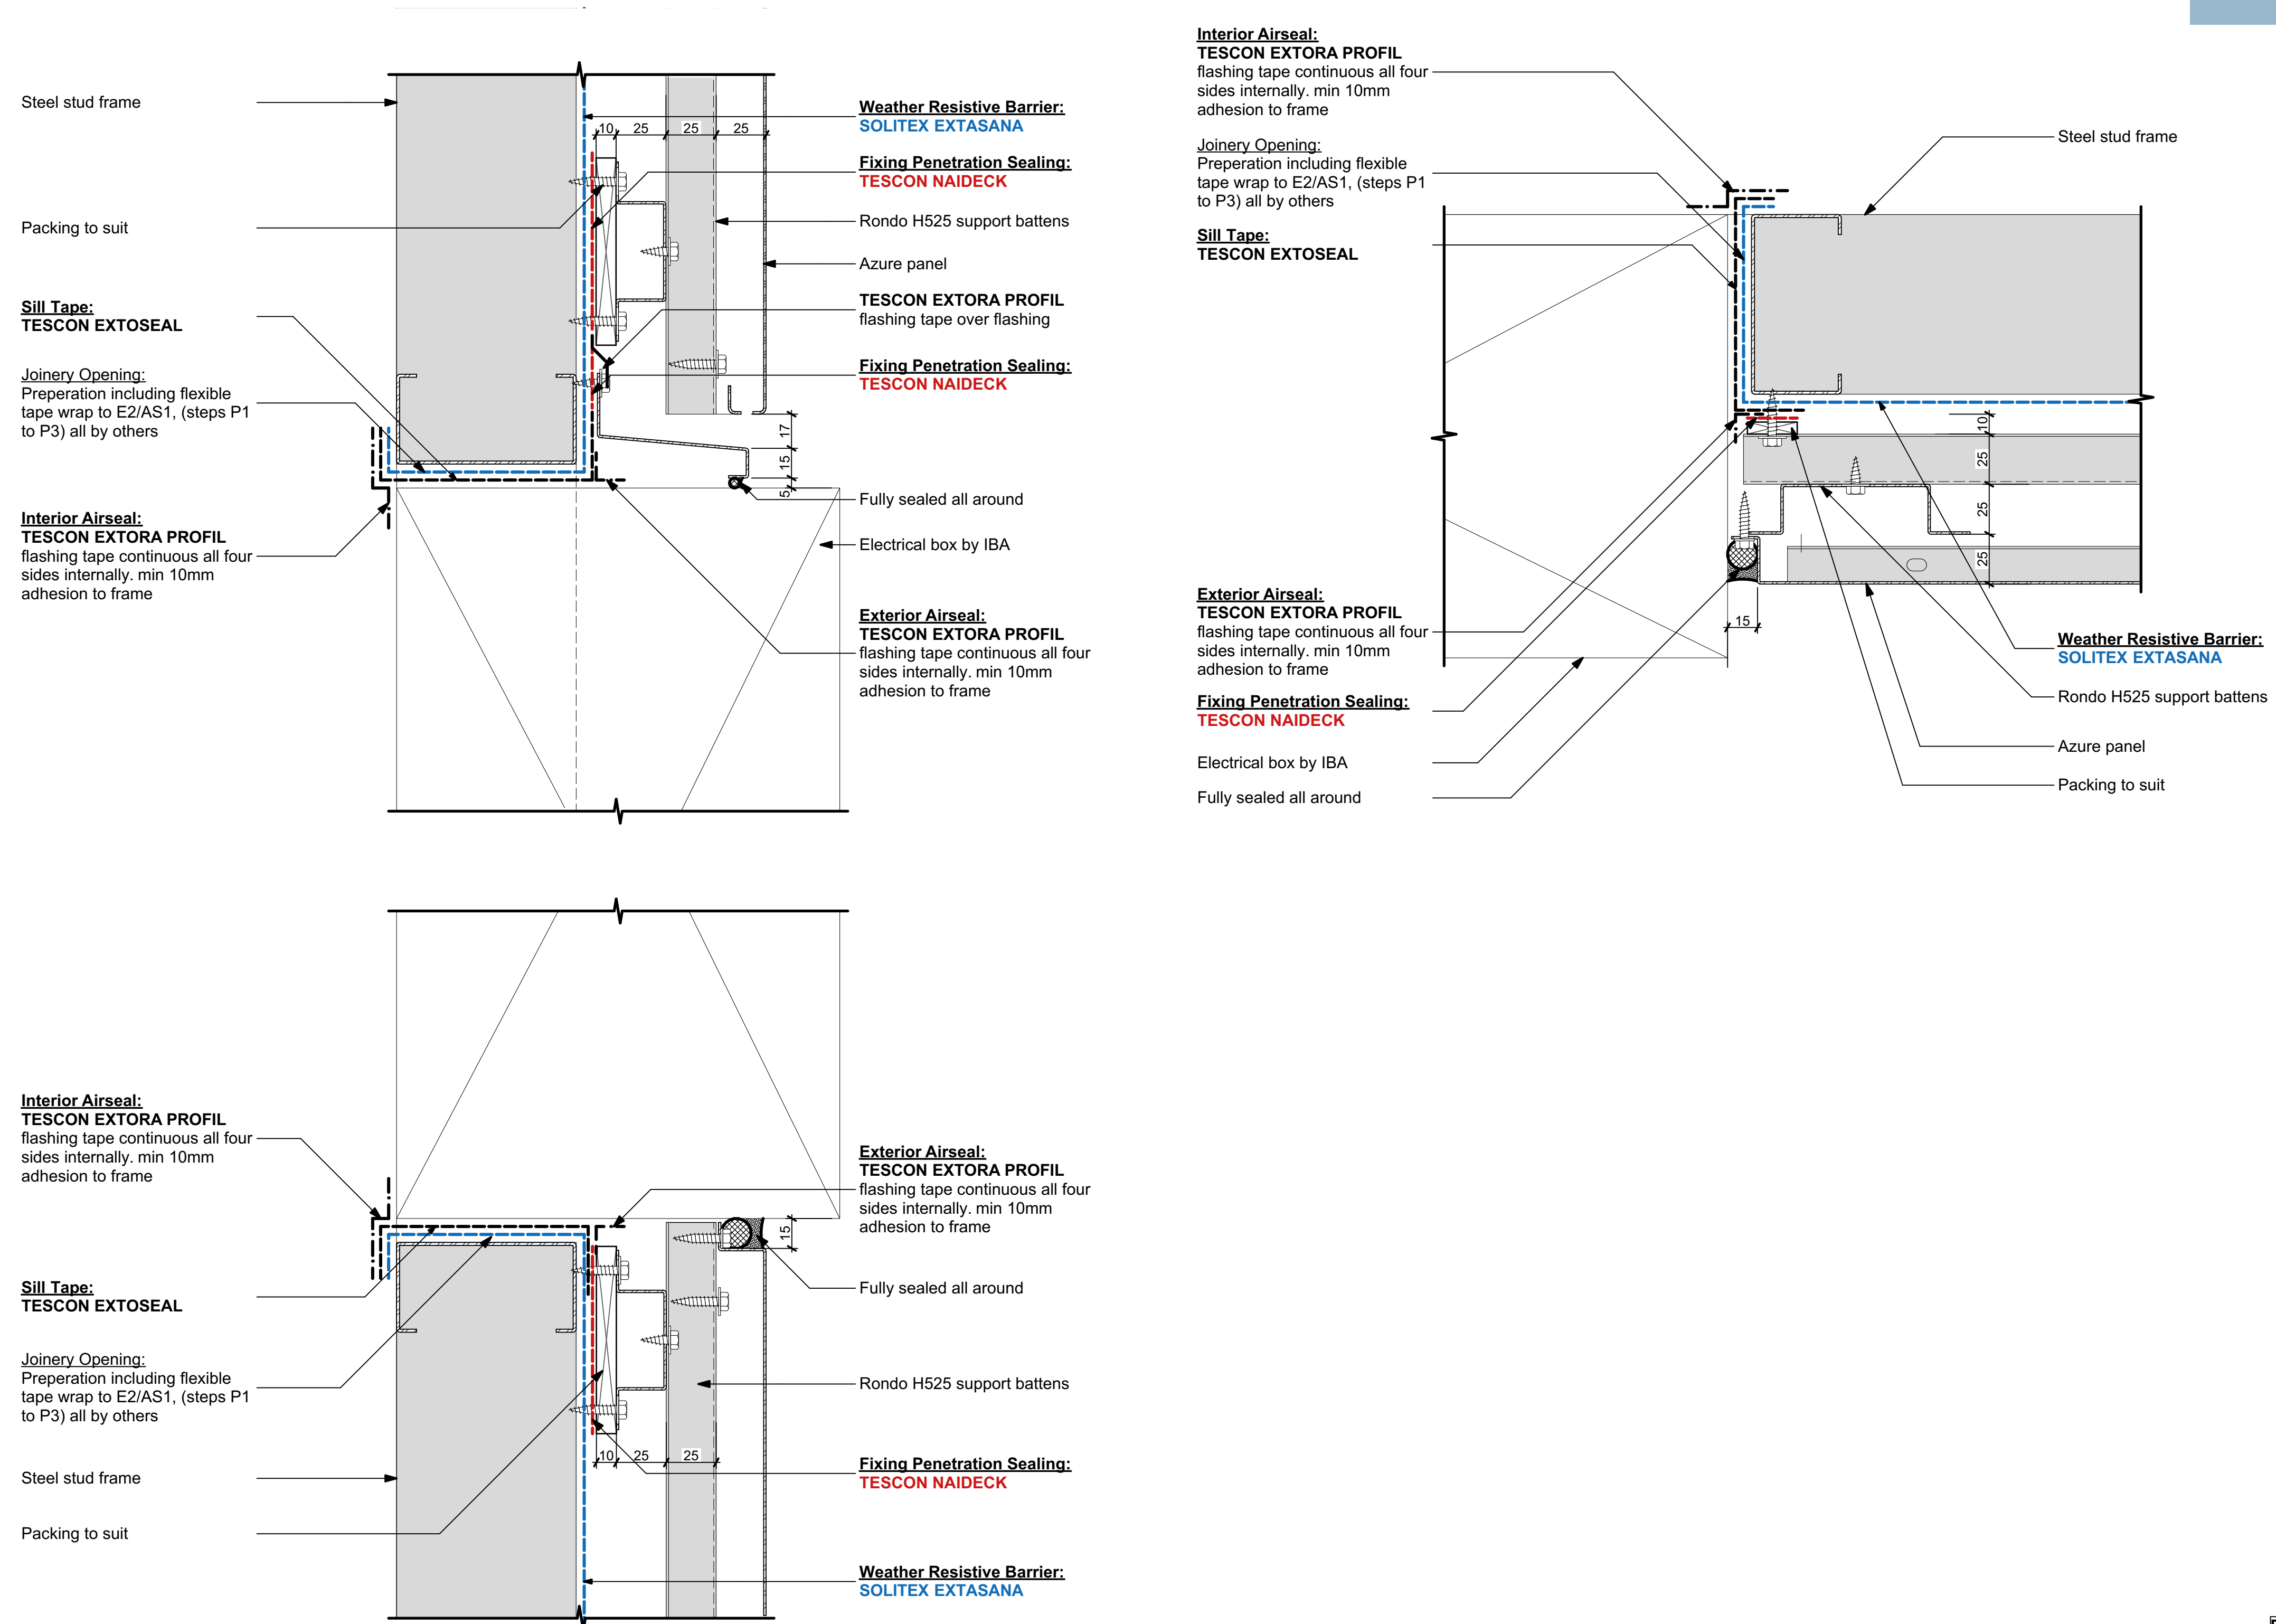
# ES4541 Service Box on Metal Structure

## Weathertight Window Connection - TESCON EXTORA® Back Seal

**Details derived from:**  
Lysaght AZURE © 100 Panel with Pro Clima SOLITEX  
EXTASANA © Weather Resistive Barrier

Test Report No. 2024-003-S1-R1

Nominated SLS ± 1.63kPa

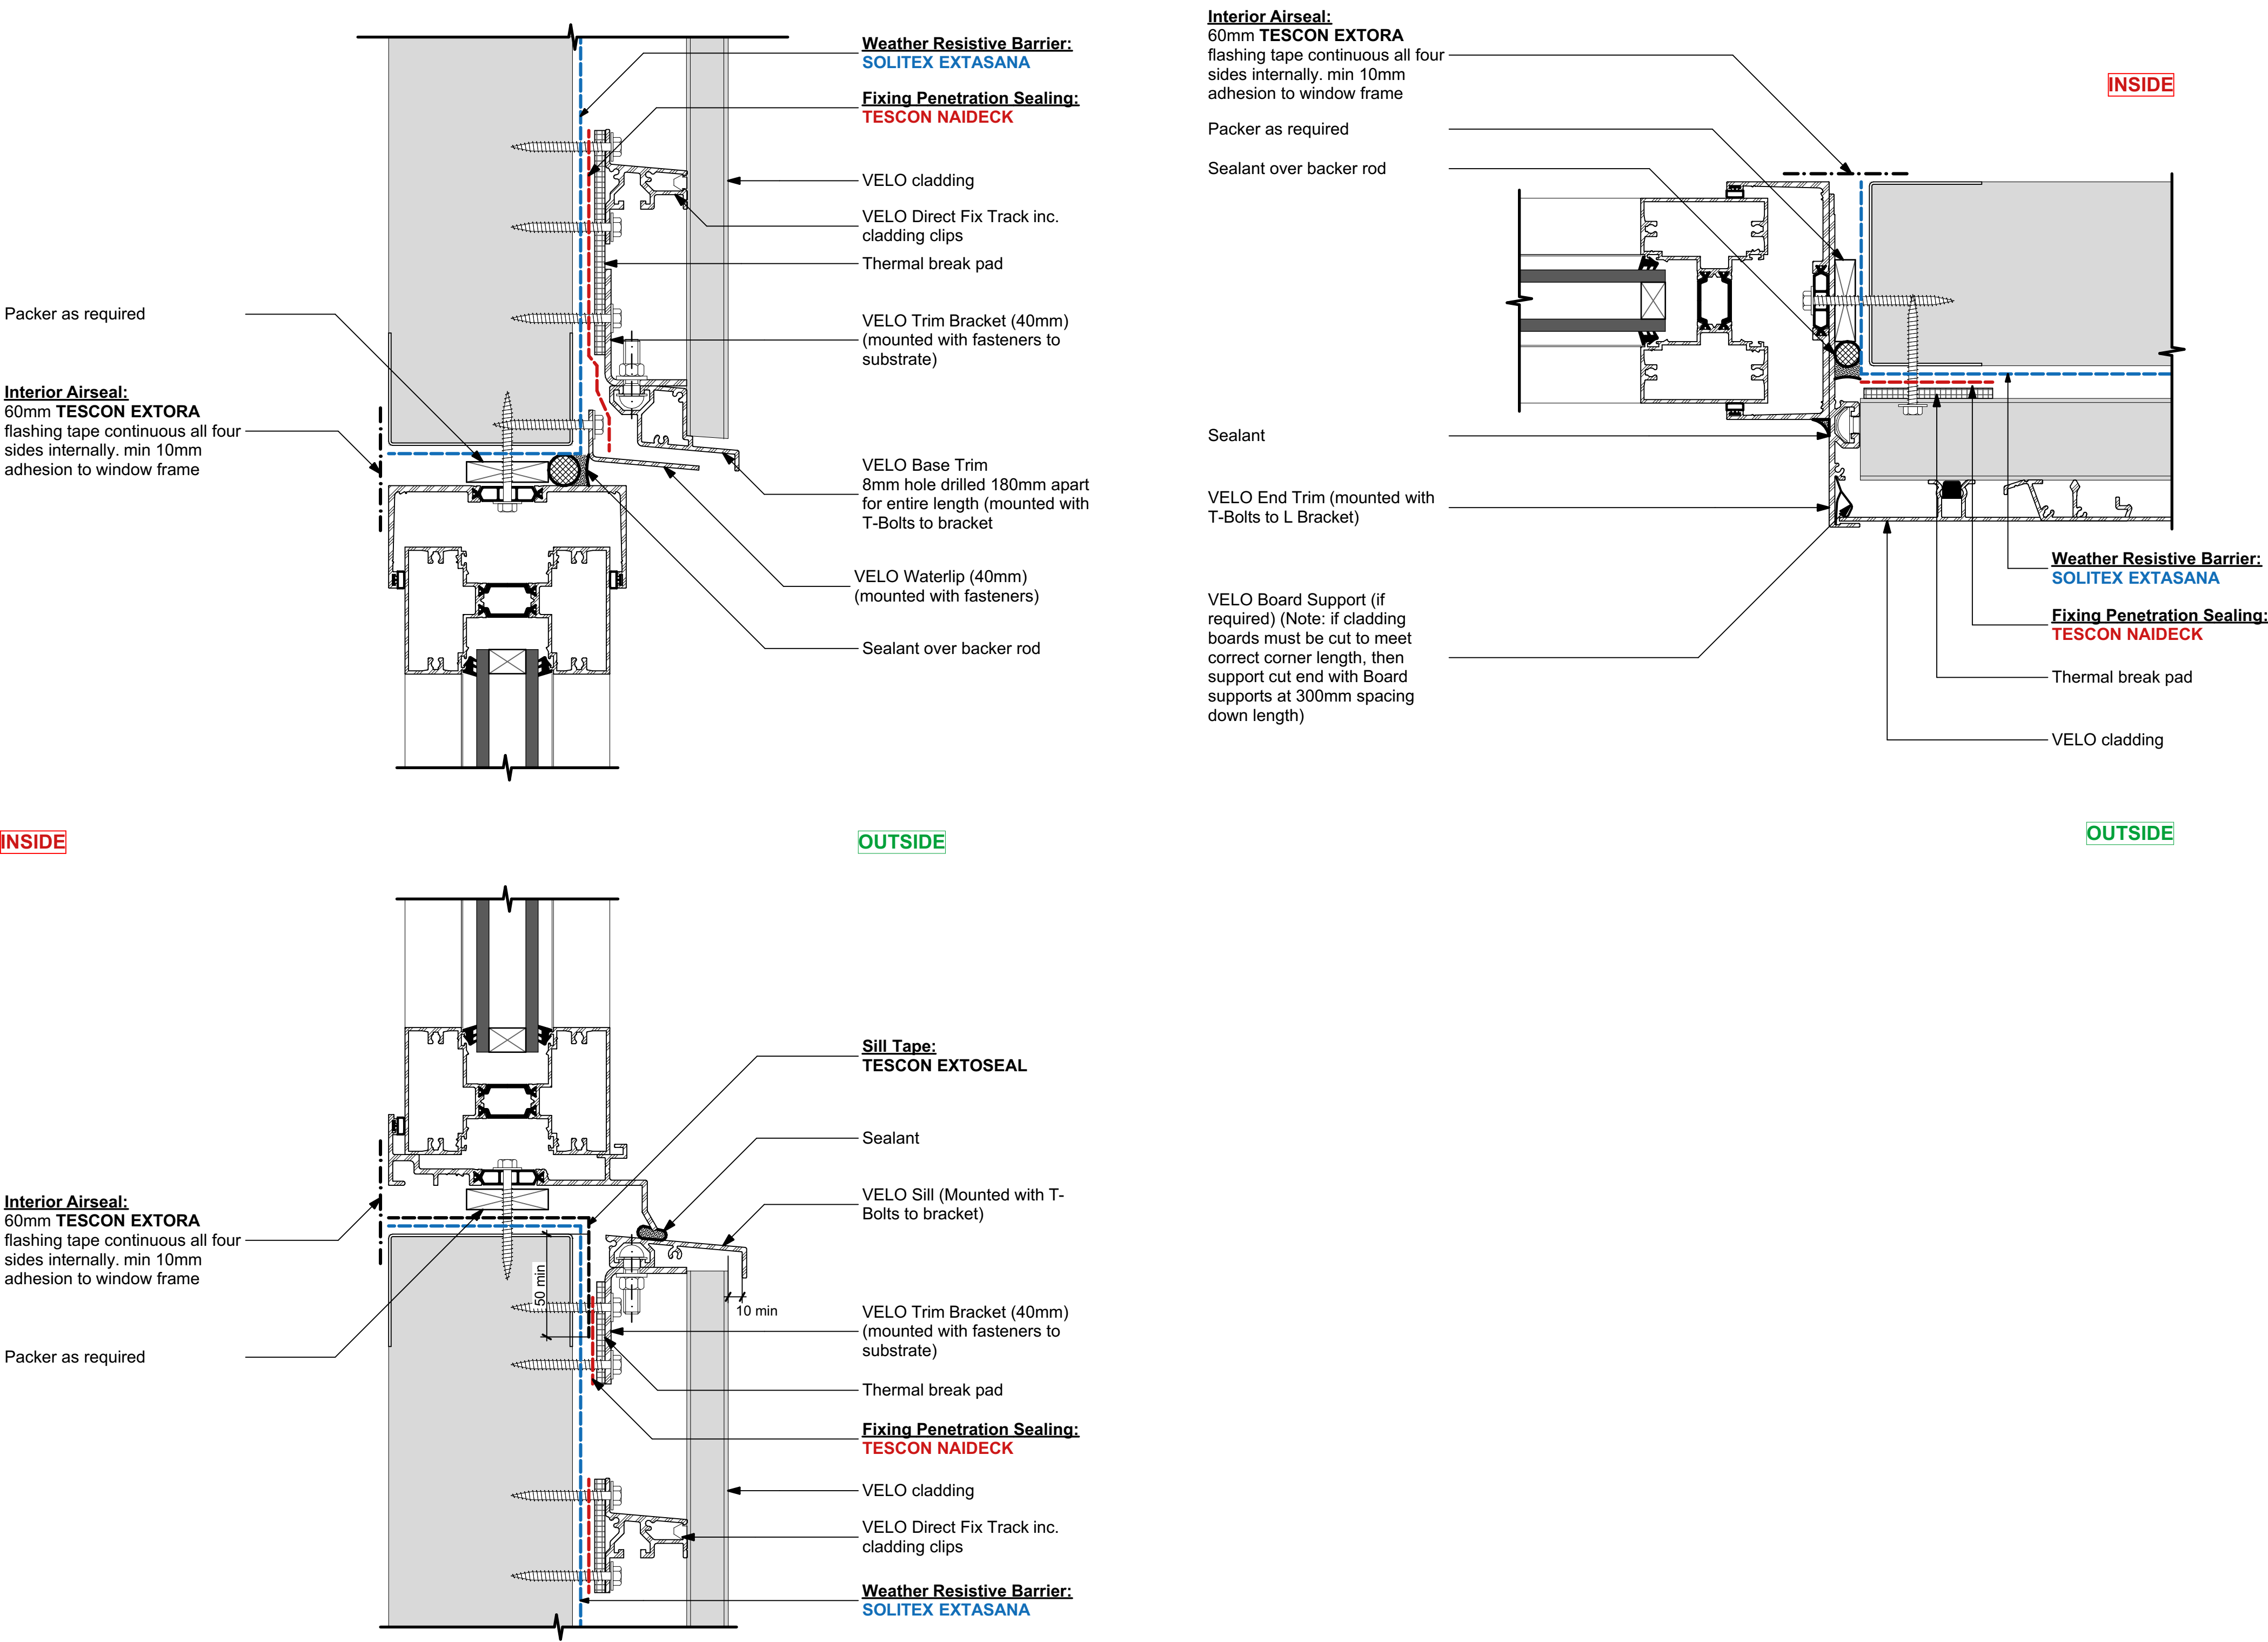
# ES4246 Commercial Recessed Aluminium Window on Metal Structure

## Weathertight Window Connection - TESCON EXTORA® Back Seal

Details derived from:  
VELO® Facades - Cavity wall  
Test Report No. 2023-050-S1  
Nominated SLS ± 2.00 kPa
