# ES4441 Residential Recessed uPVC Window on Timber Structure

## Weathertight Window Connection - TESCON EXTORA® Back Seal

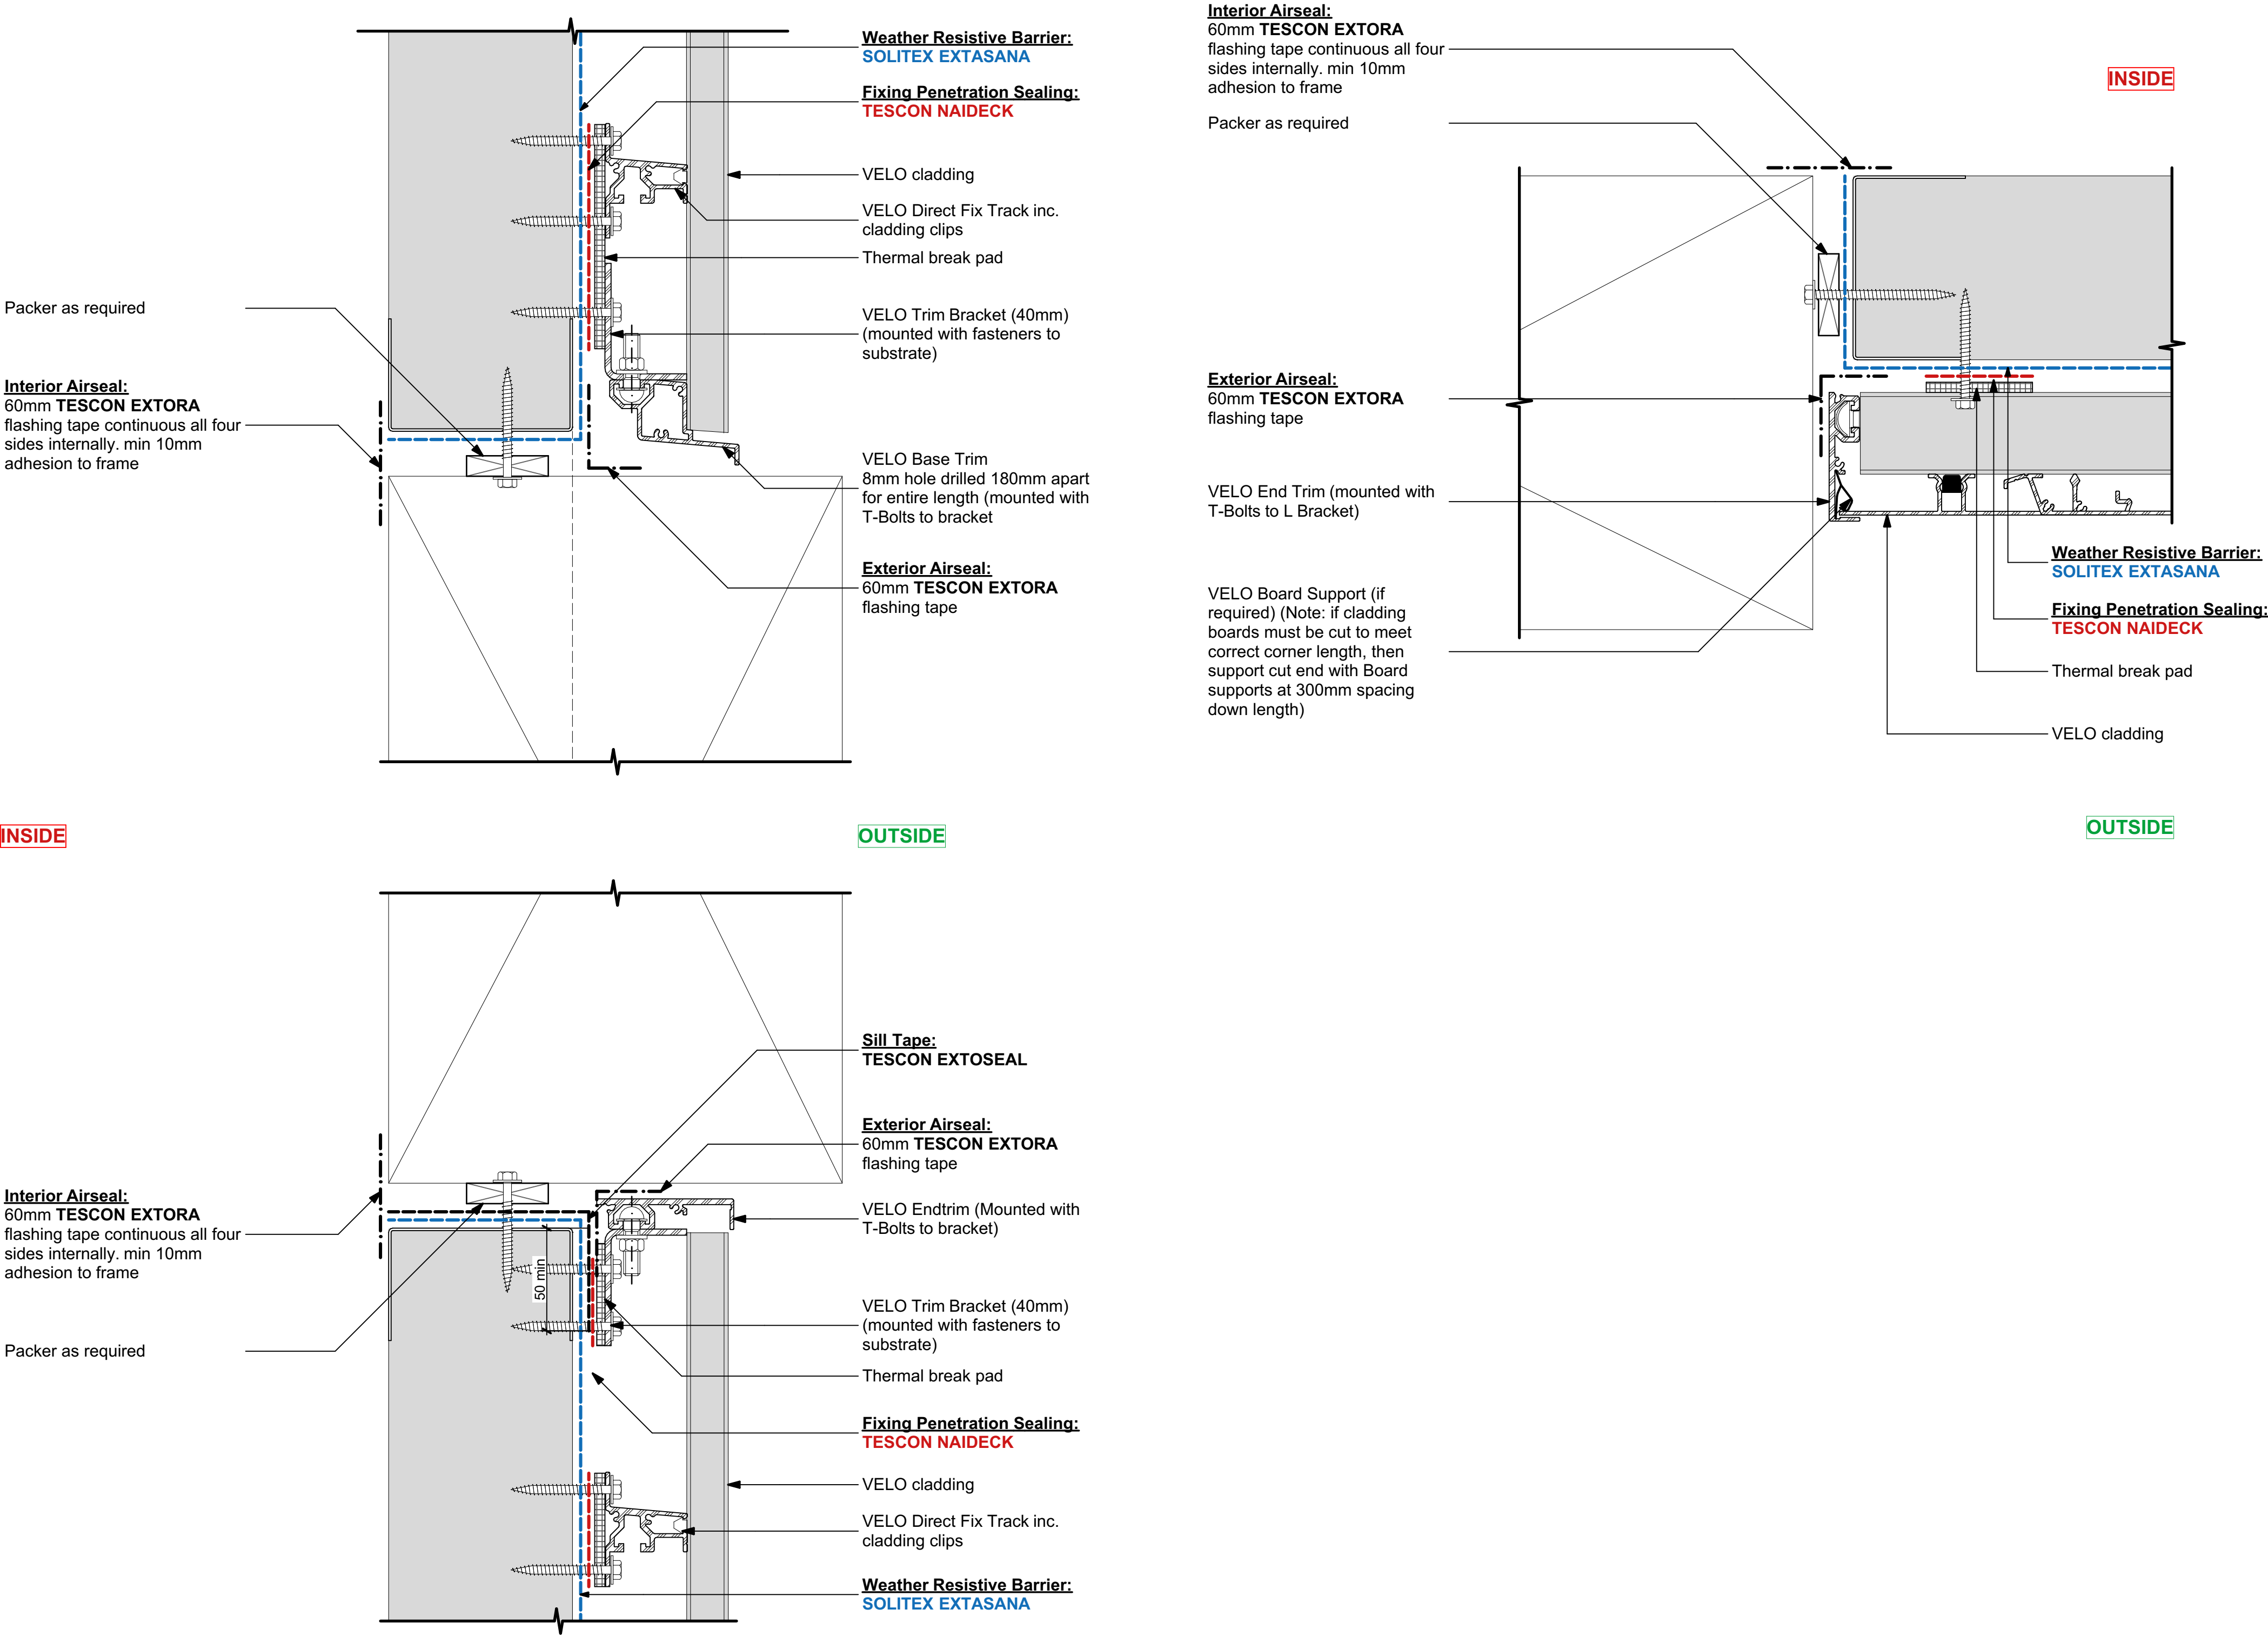
# ES4252 Service Box on Metal Structure

## Weathertight Window Connection - TESCON EXTORA® Back Seal

Details derived from:  
VELO® Facades - Cavity wall  
Test Report No. 2023-050-S1  
Nominated SLS ± 2.00 kPa

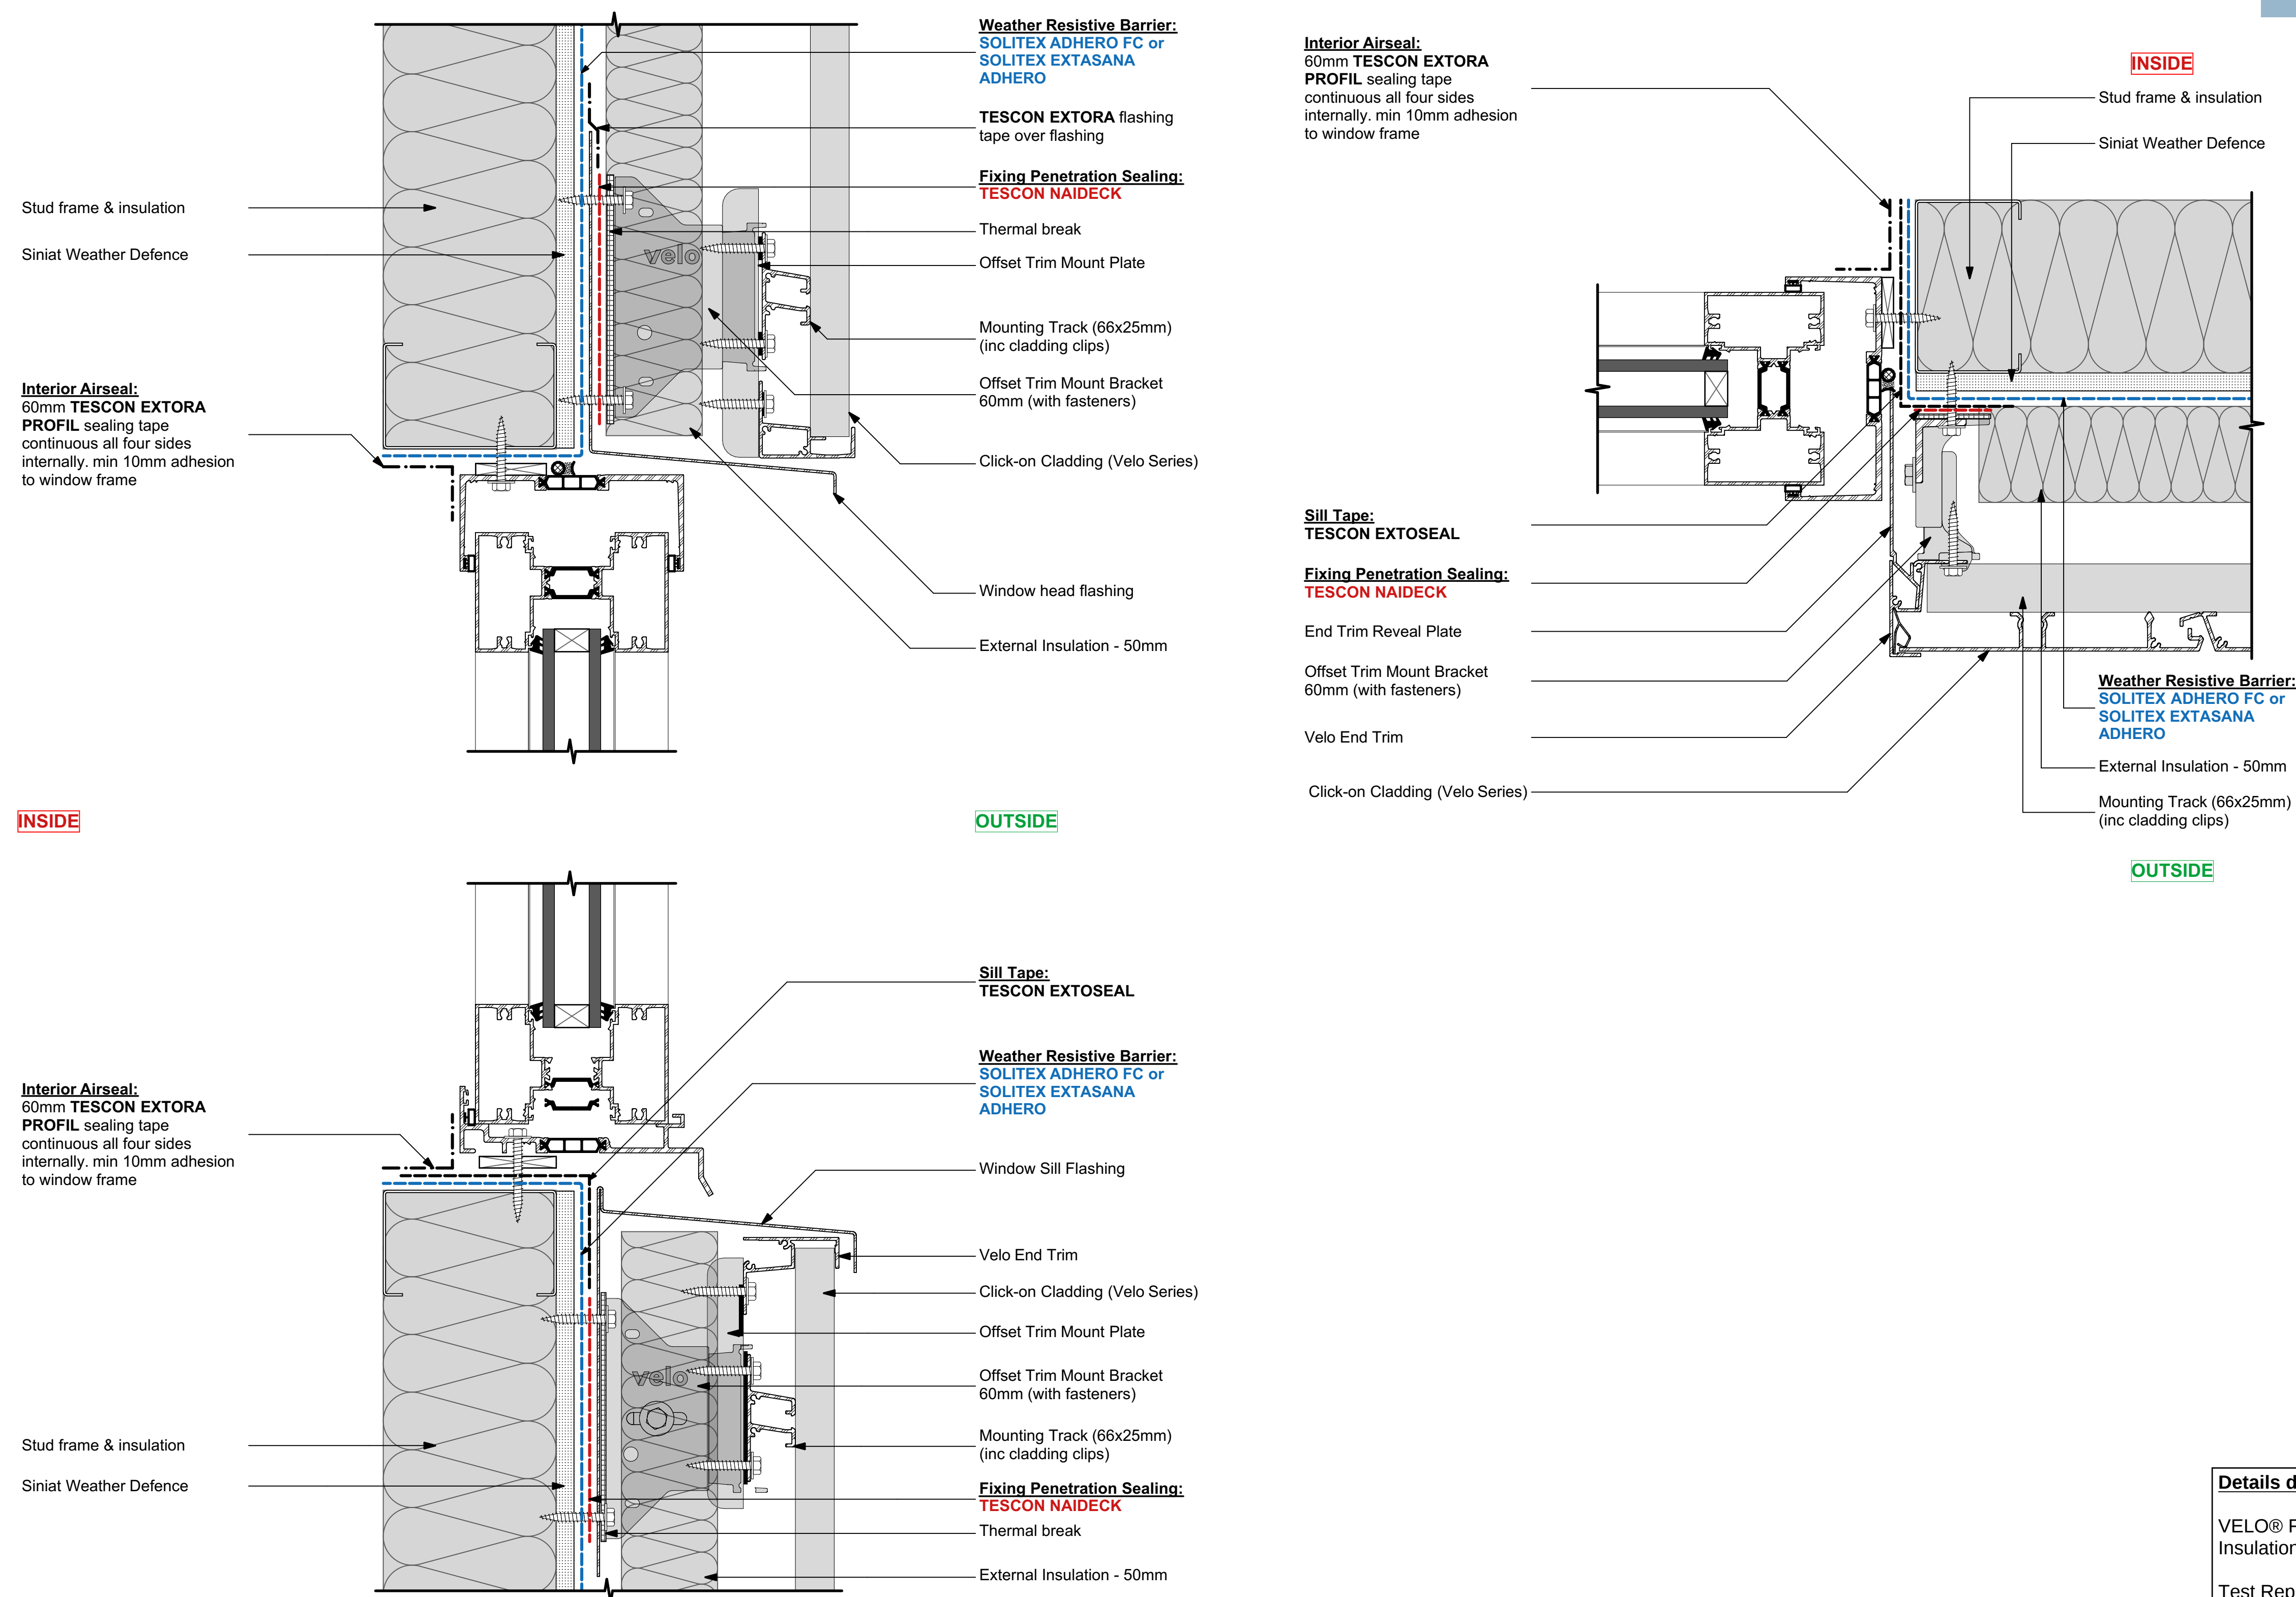
# ES4247 Commercial Recessed Aluminium Window on Metal Structure

## Weathertight Window Connection - TESCON EXTORA® Back Seal

**Details derived from:**

VELO® Facades - Aluminium Cladding with External  
Insulation, Rigid Air Barrier and Seismic joint

Test Report No. 2024-043-S1-AS4284-R1

Nominated SLS ± 3.5 kPa  
Nominated Seismic Displacement ±21mm
